AERIAL PHOTOGRAMMETRY SURVEY REPORT

Craswall Priory, Craswall, Herefordshire

AC-20-AER-005

July 2020

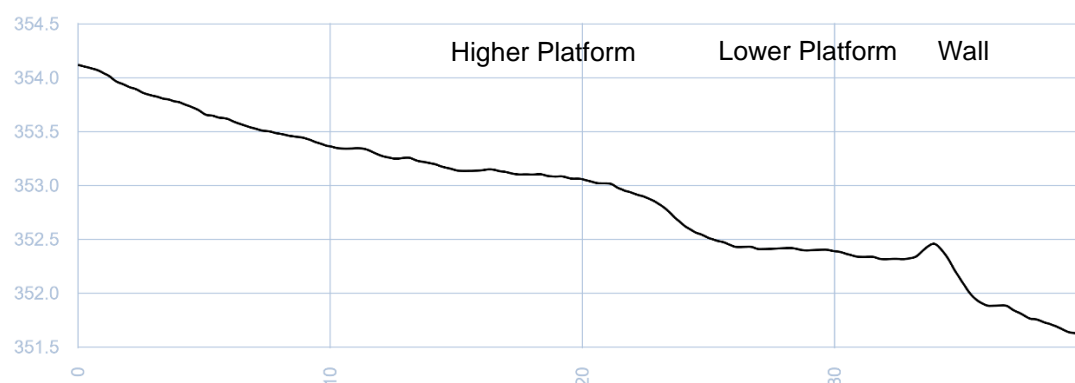
Figure 24 - Profile 1, NW-SE across precinct SE interior and wall

The section to the south-east (**C**) is visible for a length of ~35m but is also likely to continue beneath tree cover at both ends. It turns in two right angle bends, one of which creates an interior corner that contains a notably level area – possibly a platform for a building. Immediately WNW of this platform is a small scarp creating a second, slightly higher platform where a second building might have existed.

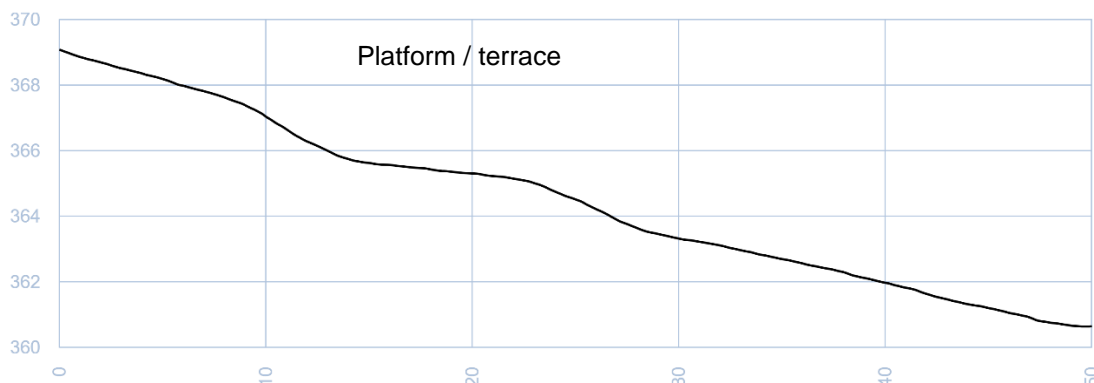
Figure 25 - Profile 2, NNE-SSW across terraced slope north of priory

Roughly 60-80m N-NNE of the priory ruins lies an area of sloped ground that has been landscaped to create two or more level spaces (**D**). These might have been cultivation terraces or platforms for buildings. One is markedly rectangular in shape (~5x10m), while the second is larger (~10x20m) and appears to have two distinct protrusions on its southern, downslope margin.

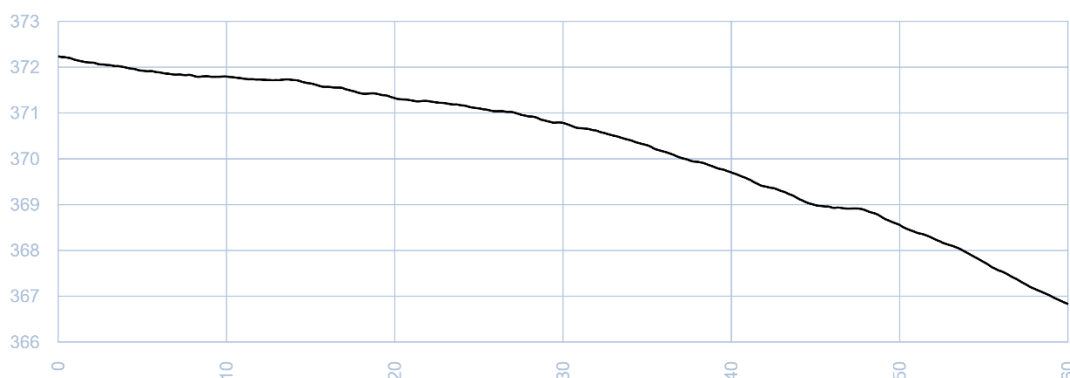
Figure 26 - Profile 3, NW-SE along linear feature south-west of quarry

Along the south-west side of the quarry lies a distinct linear feature (**F**) of uncertain purpose. It has a consistent ~4m width, a level surface and is almost perfectly straight. These attributes most closely match a track or road (it is drawn onto the interpretation plot as a 'hollowed path, track or road', though it is a positive built structure, not a negative cut feature). While it has the characteristics of a track, it is only ~60m long and does not appear to lead anywhere. It does span most of the gap between two water courses and has a consistent downhill gradient from NW to SE, so a second possibility is that it might have channelled water.

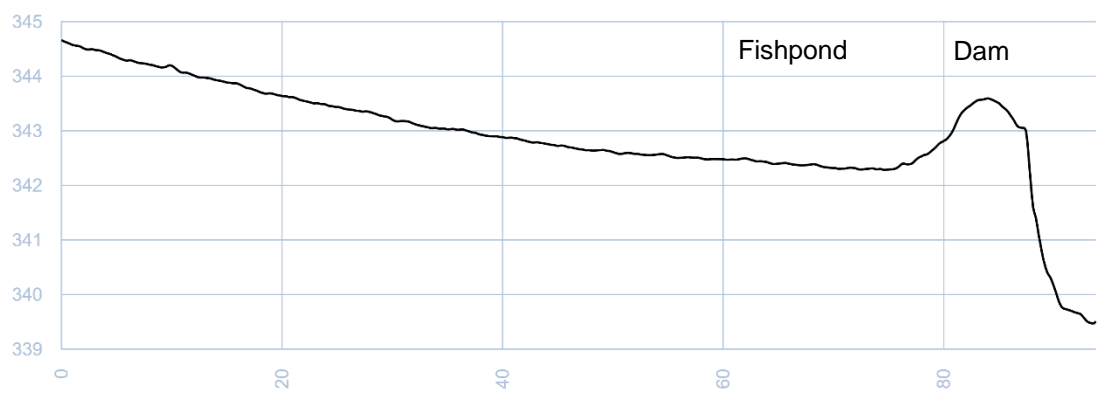
Figure 28 - Profile 5, NW-SE along former fishpond and across dam

400m south-east of the priory ruins lies a substantial dam structure (G) which spans the base of the valley. Roughly 60m of the dam are recorded in the survey data, though both ends are obscured by trees. This dam is understood to have created a fishpond which was part of the priory.

The dam rises ~4m above ground level to its south-east, but only ~1.5m above the ground level to its north-west. This might indicate the presence of substantial sediment deposits in the former pond area, potentially containing preserved archaeological and palaeoecological remains.

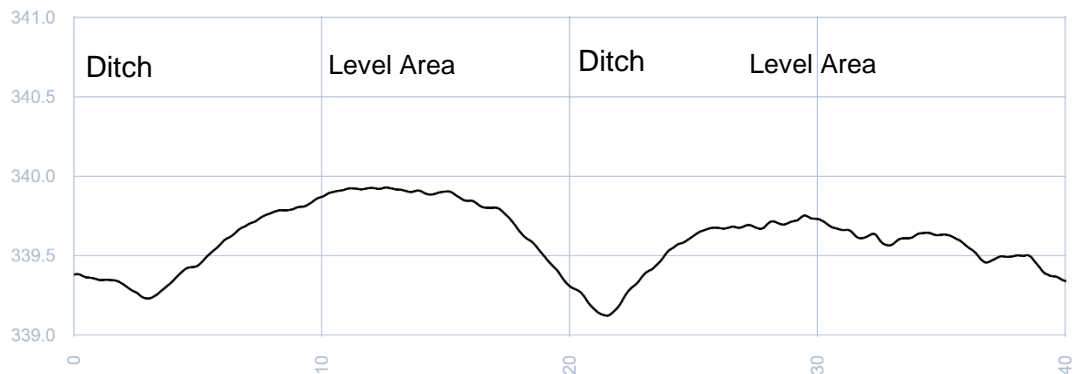
Figure 29 - Profile 6, NW-SE across possible building platforms

At the far east of the survey there is an area of relatively complex topographical features (**H**) which includes several right angles – possibly indicating the remains of structures. In particular, there are two rectangular areas that are more level than their surroundings and which could represent building platforms.

Separating these areas are a set of roughly downslope-oriented ditches, possibly related to water drainage, and one across-slope linear feature which may be a hollowed path or track.

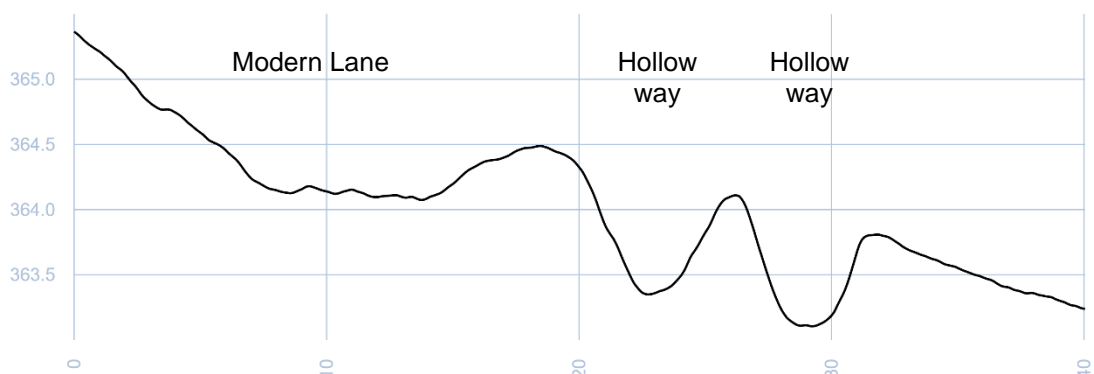
Figure 30 - Profile 7, NW-SE across close parallel hollow ways

The most prominent system of hollow ways runs SSW to NNE through the western third of the survey area. Multiple routes converge to cross a ford (**I**) 20m west of the priory ruins. North of the ford, the route continues NNE towards Abbey Farm, splitting into two, which run almost parallel for around 50m. Beyond Abbey Farm the routes diverge, with the most deeply eroded tracks turning left (**J**) to leave the area to the north-west. Much of this system corresponds with a road shown on Ordnance Survey maps from the earliest (1887) onwards, and which was replaced by the modern lane between 1963 and 1973. This is likely to have been the primary road through the area over much of the 19th and 20th centuries, and perhaps also preceding centuries. As such, relatively modern activity could account for its depth and there may be no reason to assume it was in use during the mediaeval period. Additionally, historic Ordnance Survey maps show this route cutting obliquely through the precinct walls – possibly indicating a later date.

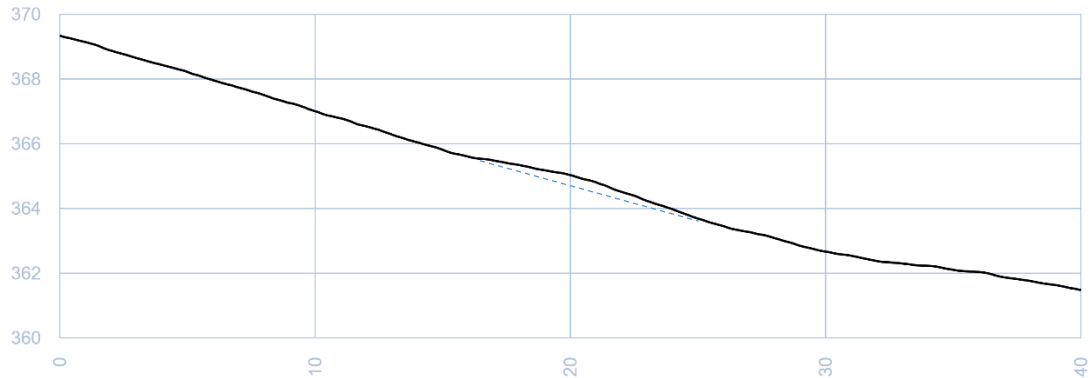
Figure 31 - Profile 8, NE-SW across earthwork bank or lynchet

Some of these features (**K**) have a morphology consistent with lynchets and might have existed only as hedgerows.

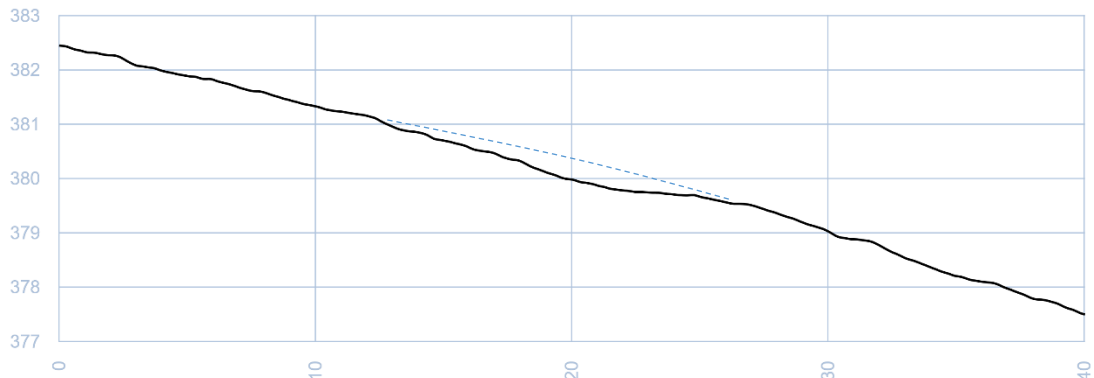
Figure 32 - Profile 9, NW-SE across possible boundary ditch

Others have forms that suggest deliberate construction as banks and/or ditches. One (**L**) appears to be formed primarily as a ditch, perhaps with very slight banks on either side. Another (**M**) may be comprised of two ditches. These features may be more significant than just field boundaries – perhaps marking the bounds of an estate, for example.
