# Snodhill Castle, Peterchurch, Herefordshire: Archaeological, Architectural and Aerial Survey and Investigation

Research Report Series 076-2017

**SNODHILL CASTLE  
PETERCHURCH  
HEREFORDSHIRE**

**ARCHAEOLOGICAL, ARCHITECTURAL AND AERIAL  
INVESTIGATION AND SURVEY**

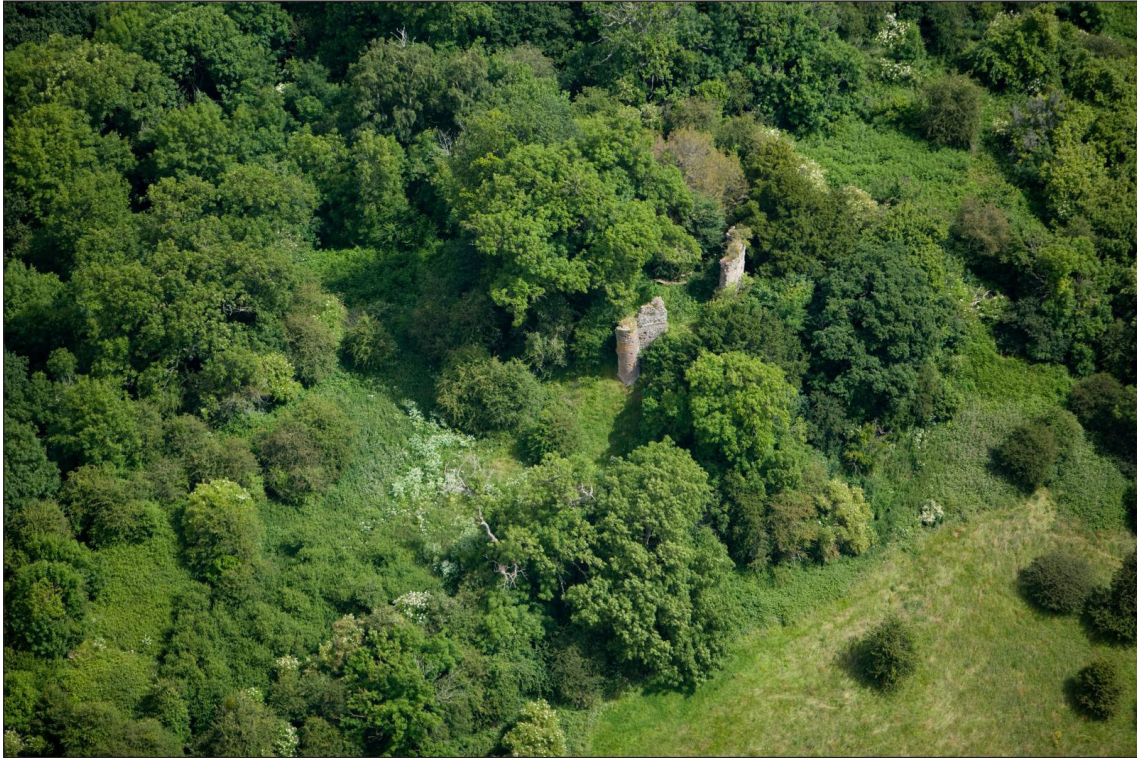
*Figure 2 The overgrown site of Snodhill Castle in the summer of 2008 with the ruins of the great tower amongst the trees. HEA 26042\_009 30-JUN-2008*

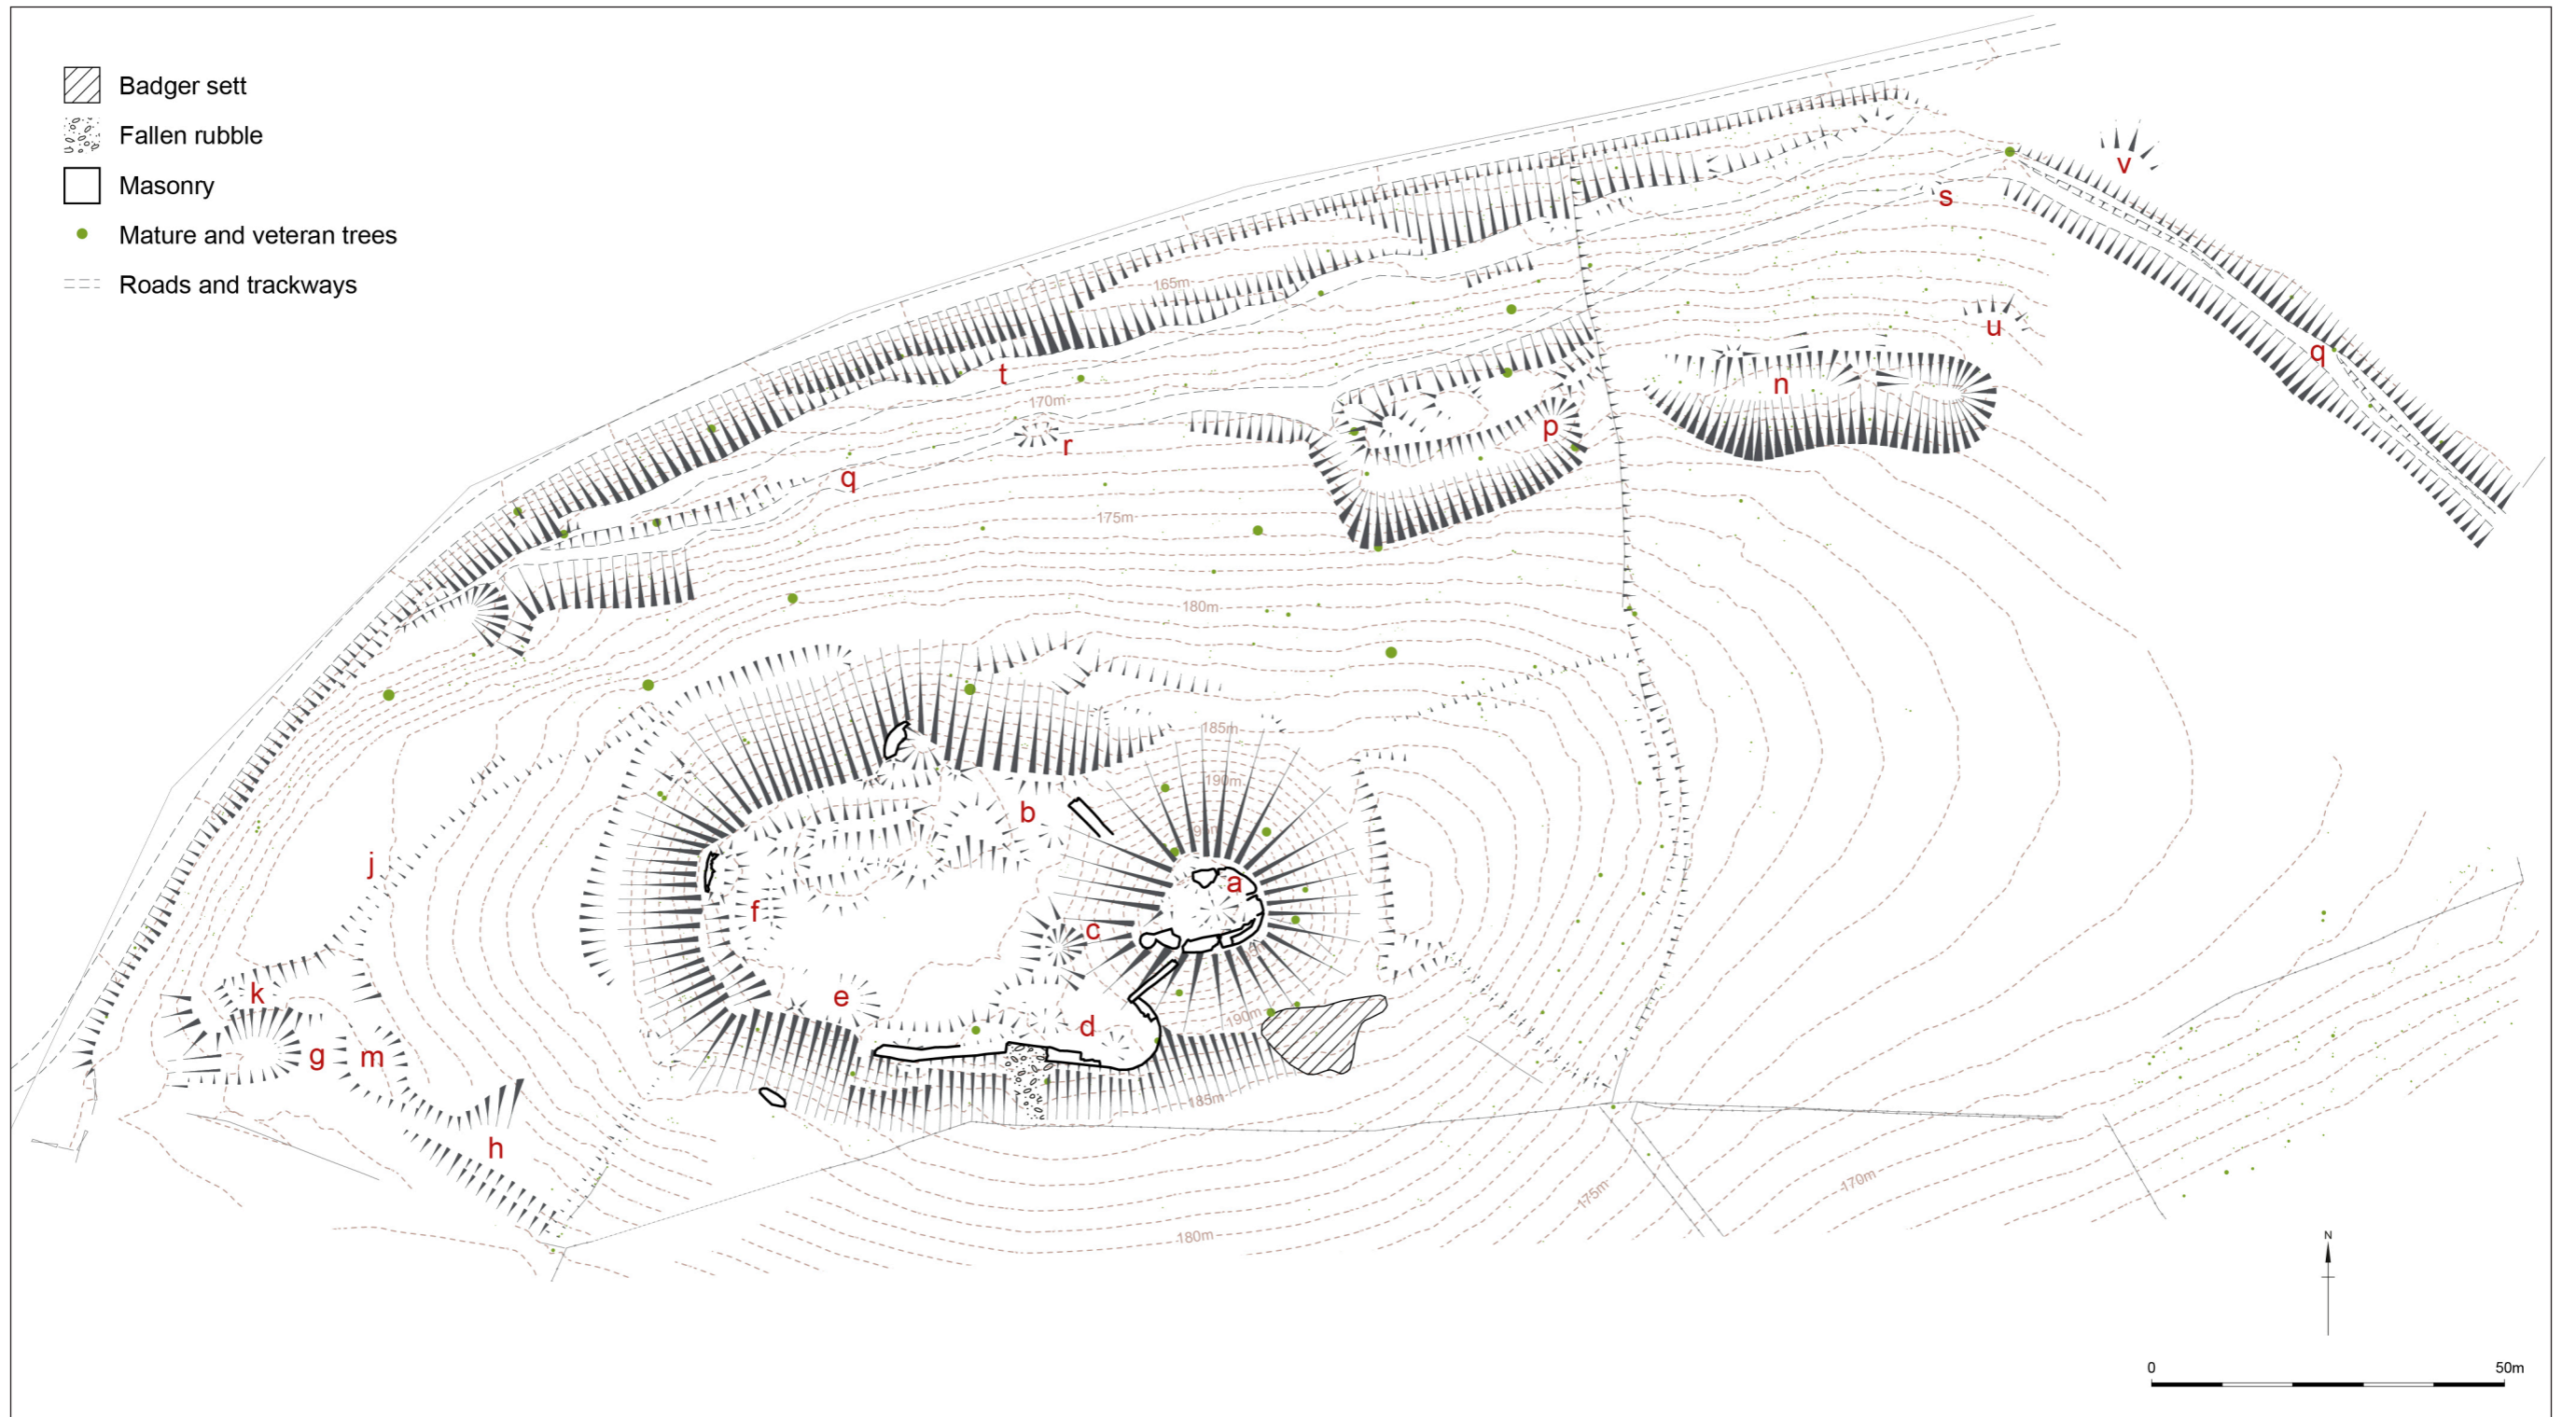
Figure 4 Historic England 1:1000 earthwork survey (reduced)

The motte is steep-sided, standing about 7.4m high above the bailey, 9.7m above the ditch to its east and as much as 14m above the terrace to the north. The maximum diameter of the foot of the motte is about 44m. The summit, which has been much modified by the building of the great tower, measures about 15m east-west by 12.5m transversely; it was possibly circular originally but has been apparently elongated by the construction of the later masonry gate. In the centre is a sub-rectangular hollow (Figure 4 - **a**) about 0.2m deep; this has been interpreted variously as the robbed out foundation of a central pillar, as a light well (see discussion of great tower below), or as a tree-throw or antiquarian trench. The remains of wing walls that would have connected the great tower to the curtain wall survive on the sides of the motte. The flanks of the motte have been much damaged by badger setts, particularly on the east and south sides. It also supports a number of mature yew and ash trees. The motte is separated from the ridge to the east by a ditch which is now 1.5m deep to the exterior where there is a slight counterscarp. There is no sign of a ditch on the sides of the ridge to north or south where the natural slope falls away steeply, though there is a ledge or terrace on the north side, a continuation of the route leading around the north side of the bailey (see below). More significantly, perhaps, there is no sign of a ditch dividing the motte from the bailey to the west, with the possible exception of a very slight scoop (**b**), no more than 0.2m deep. There is a much more substantial hollow (**c**) at the foot of the motte immediately below the great tower entrance; this hollow is enhanced by a bank on its west side. It has been interpreted as part of the access arrangements to the motte and this may be the case but it should be noted that the earthwork is well-defined and sharp, and may be the result of relatively recent disturbance – that disturbance might, of course, be the robbing of a masonry gate tower, bridge pier, drawbridge pit or similar structure.

A track leads up from the modern gate at the extreme west end of the site and divides at **(g)**: a modern path leads straight upslope and over the south-western corner of the bailey; this is not an original route – it is too steep and, as noted above, it cuts across one of the buildings inside the bailey; another track leads south-eastwards **(h)** where it overlies one of the building platforms but is cut by a redundant but relatively recent hedge bank, anchoring it in the relative chronology of the site; a second track **(j)** leads in a north-easterly direction and continues around the northern side of the inner bailey ditch.

There are two possible building platforms within this area. One **(k)** is cut into a substantial slope and seems to represent a narrow rectangular building with two subdivisions. The other is less well-defined but seems to be a larger building **(m)** laid out at right angles to the former at the foot of the natural slope; its south-western corner has been cut and smoothed by track **(h)**. Track **(j)** runs between the two buildings. These buildings could relate to the castle but could equally represent a small farmstead. However, it should be noted that building **(m)** is of some antiquity

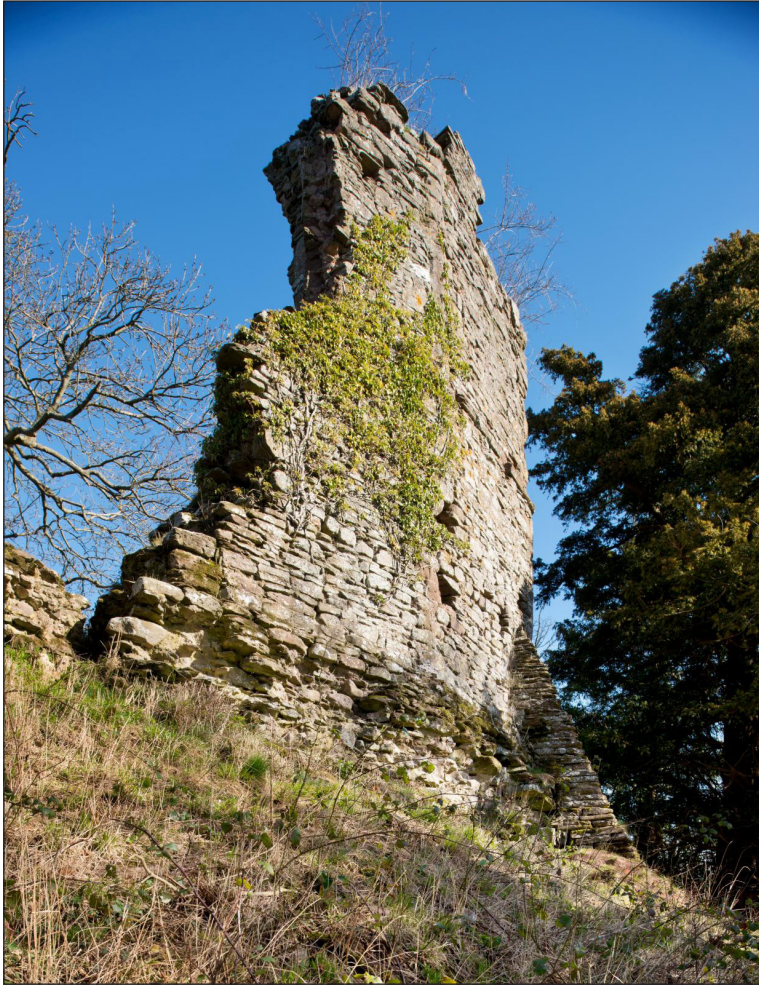
*Figure 5 Southeast corner of the tower showing the remains of the plinth at ground floor level (DP195780).*

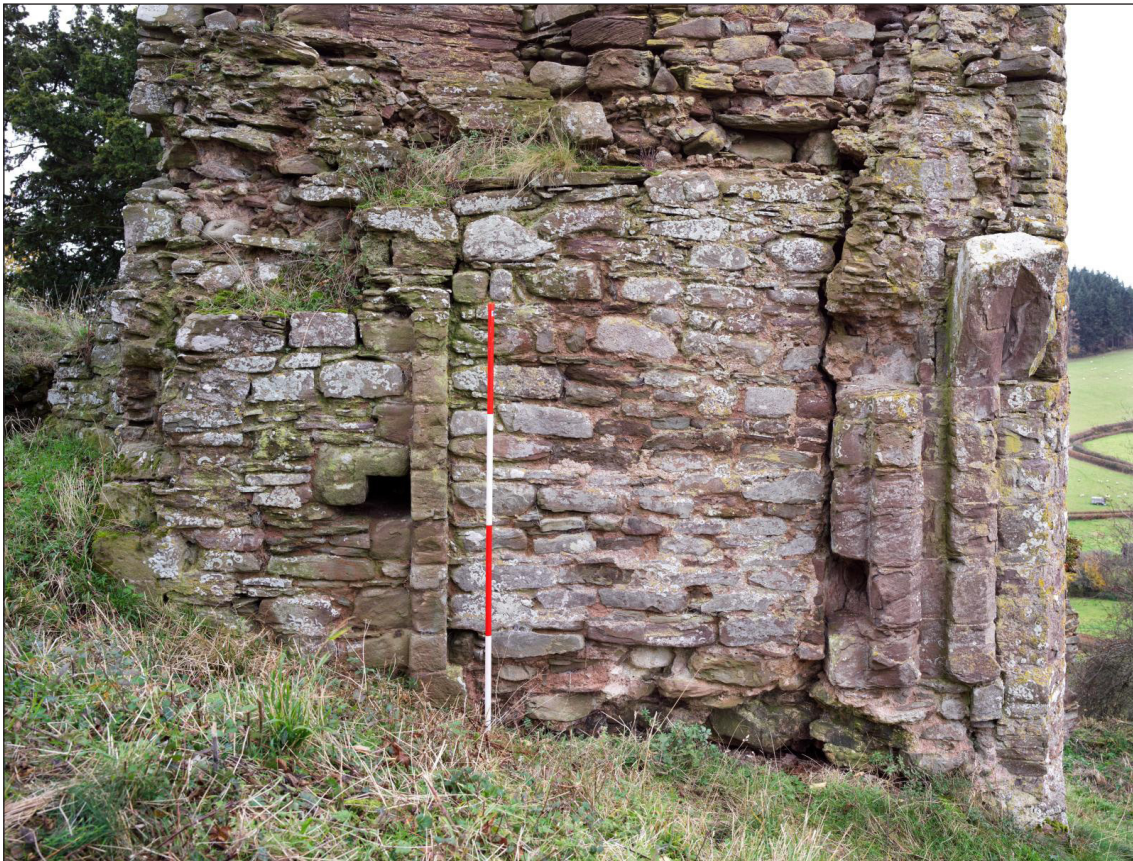
*Figure 6 Ground floor entrance passage showing remains of door jamb (DP195368).*

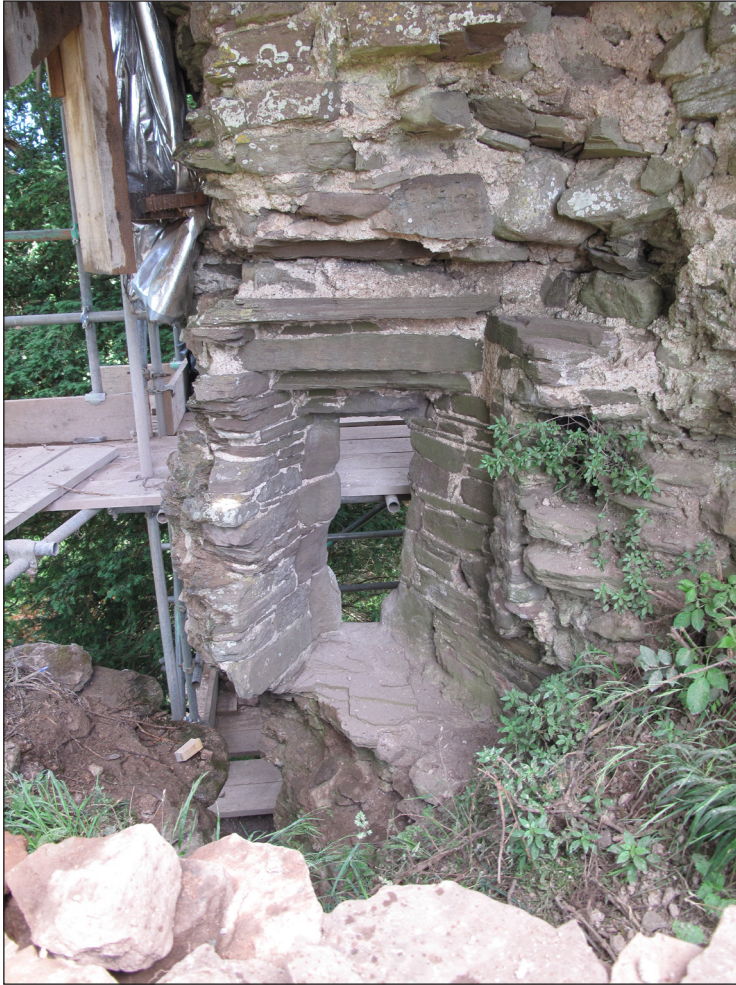
*Figure 7 Small window opening to the southeast of the tower (Photograph Rebecca Lane).*

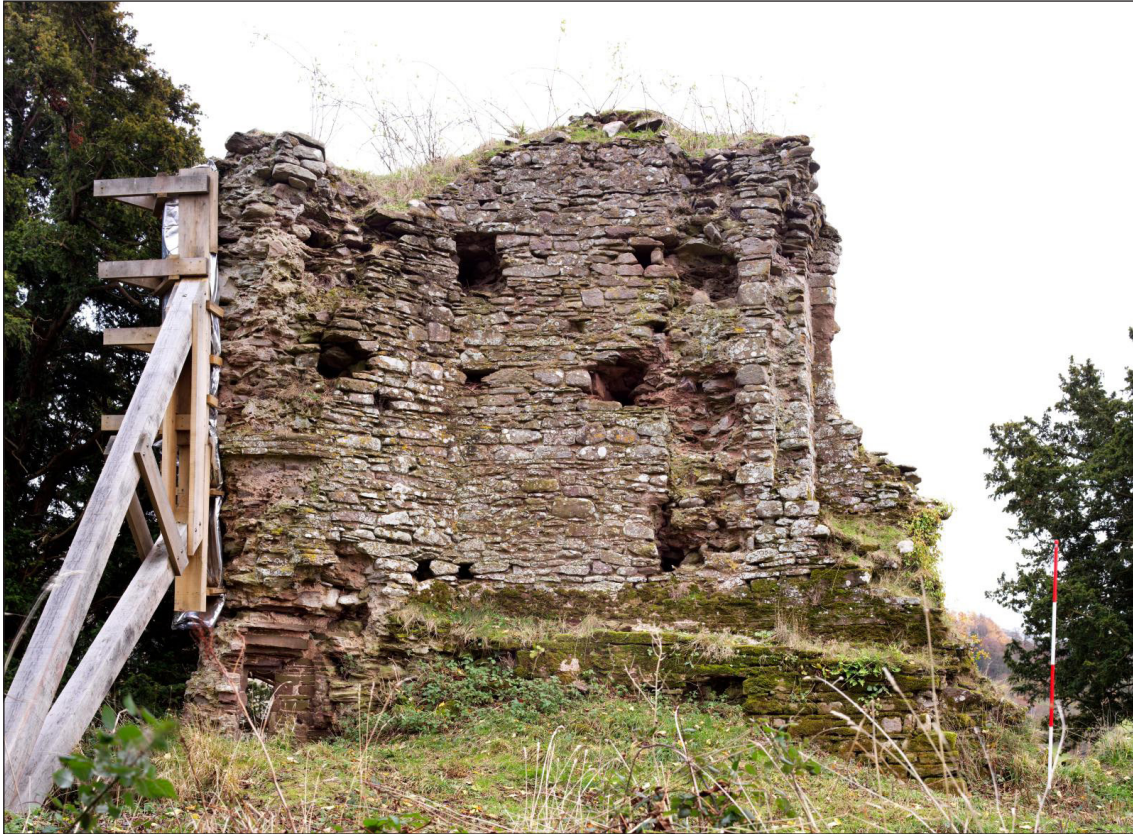
Above ground-floor level there is a significant offset in the walling internally, marking the floor level of the first floor above (Figure 8). There is no indication of any vaulting associated with the ceiling of the ground-floor, so the floor was almost certainly supported on timber joists. No joist holes could be identified in the upper

*Figure 8 Internal elevation of the south-eastern corner of the tower, showing the offset between ground- and first-floor level (DP195363).*

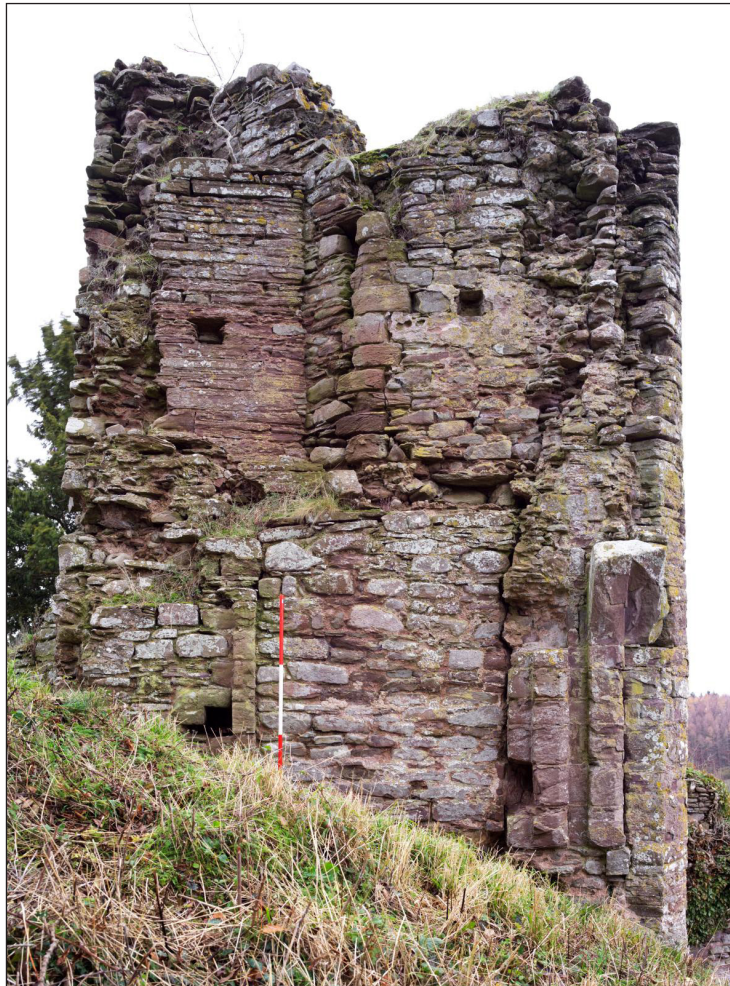
*Figure 10 Southwest  
corner of the tower,  
interior, showing the  
surviving western  
opening at first-floor level  
(DP195367).*

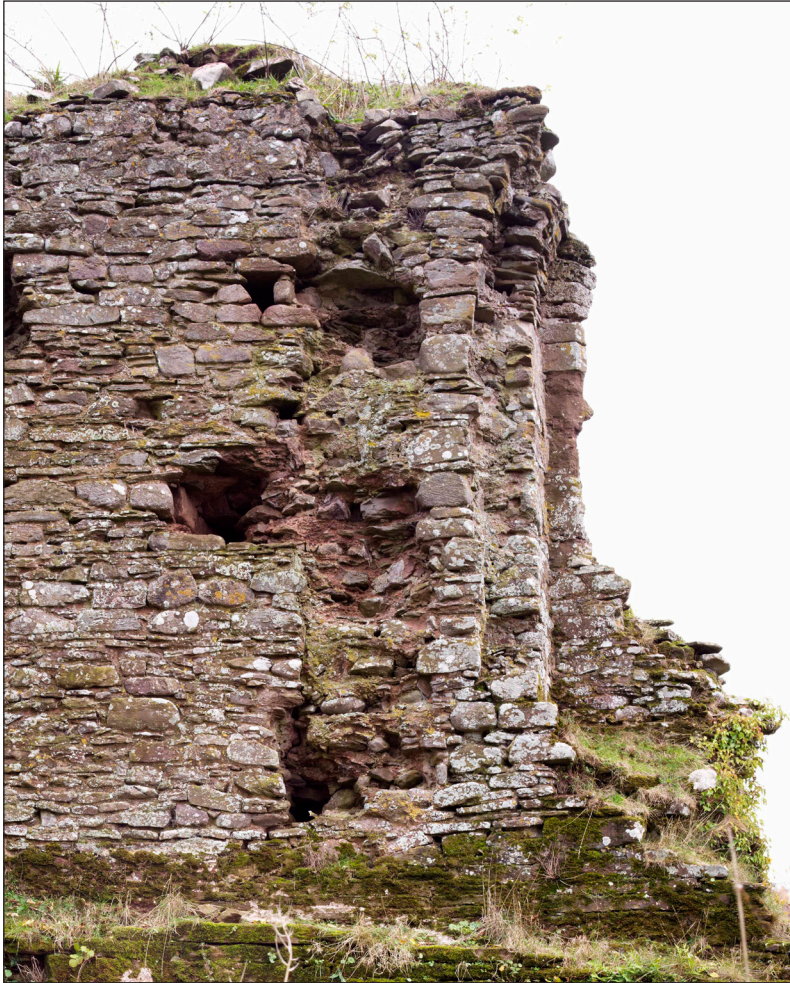
*Figure 11 Exposed rubble core, possibly marking the position of a further subdivision in the building (DP195363 cropped).*

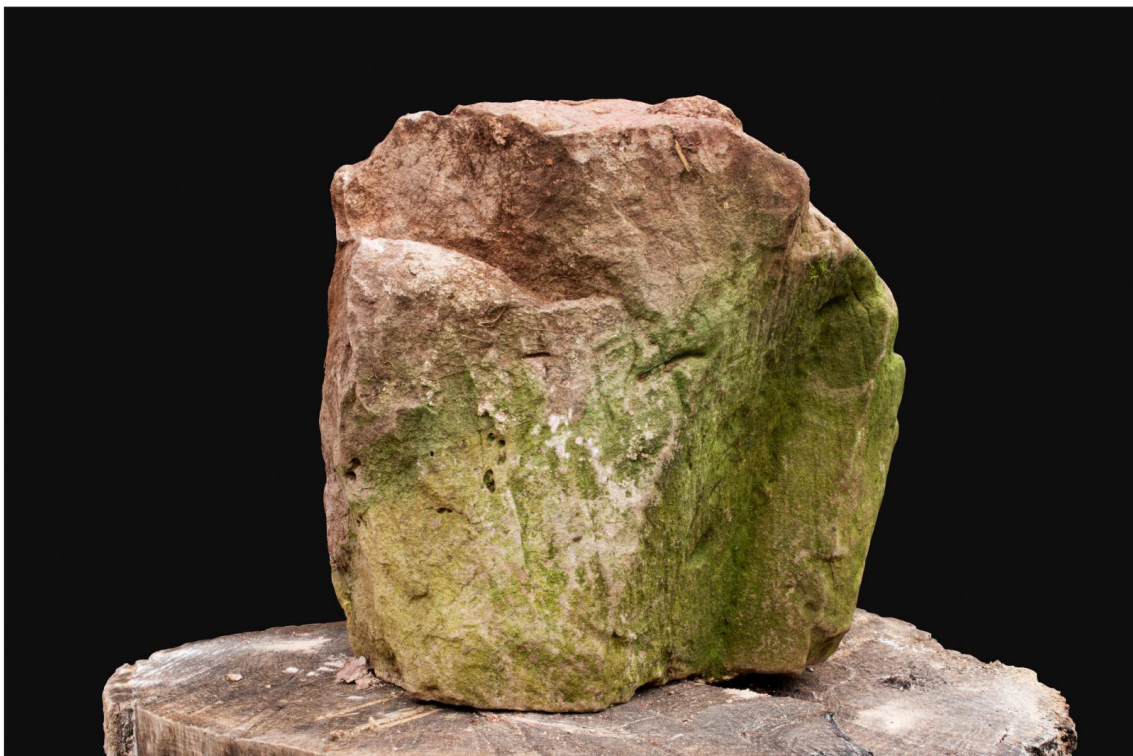
*Figure 12 Section of the springing of the arched window head, identified in the rubble at the base of the motte (DP195818).*

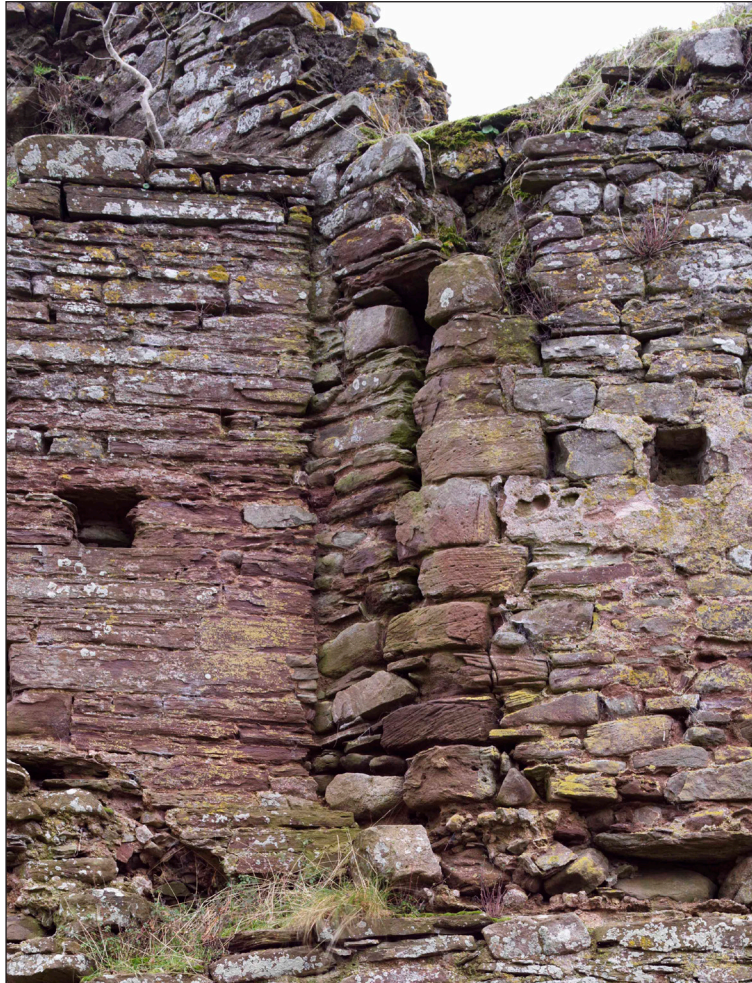
Figure 13 Quoins marking the original return of the main internal wall for the western opening (DP195367 cropped).

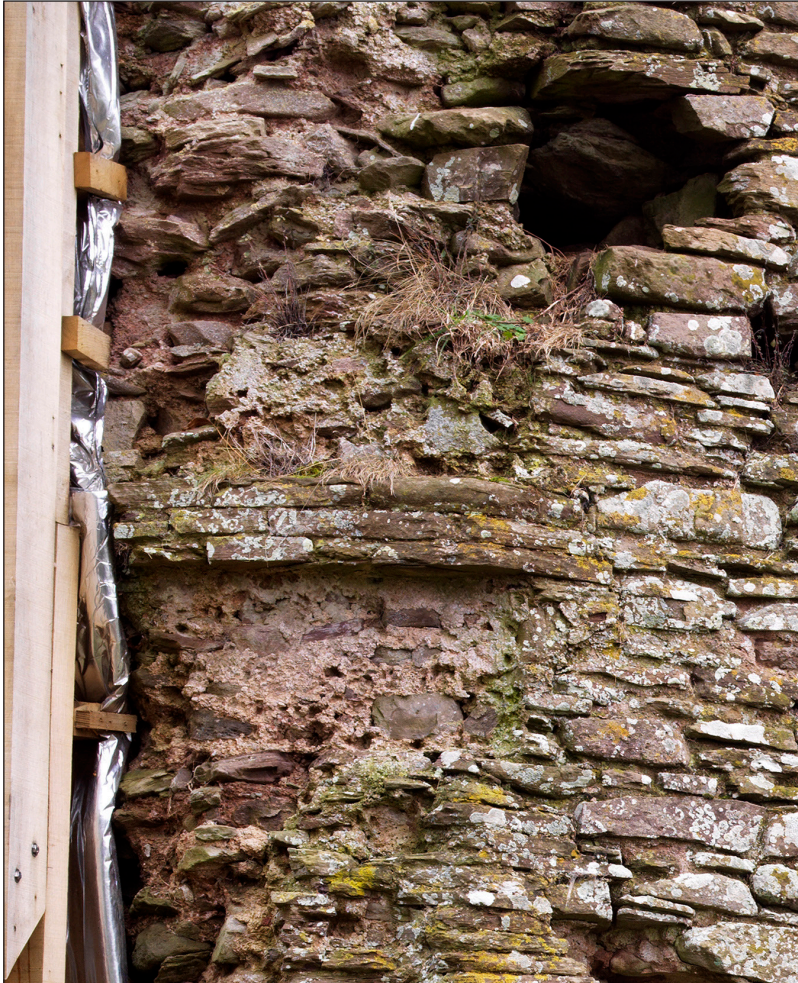
*Figure 14 Surviving section of splay for window at the east end of the tower (DP195363 cropped).*

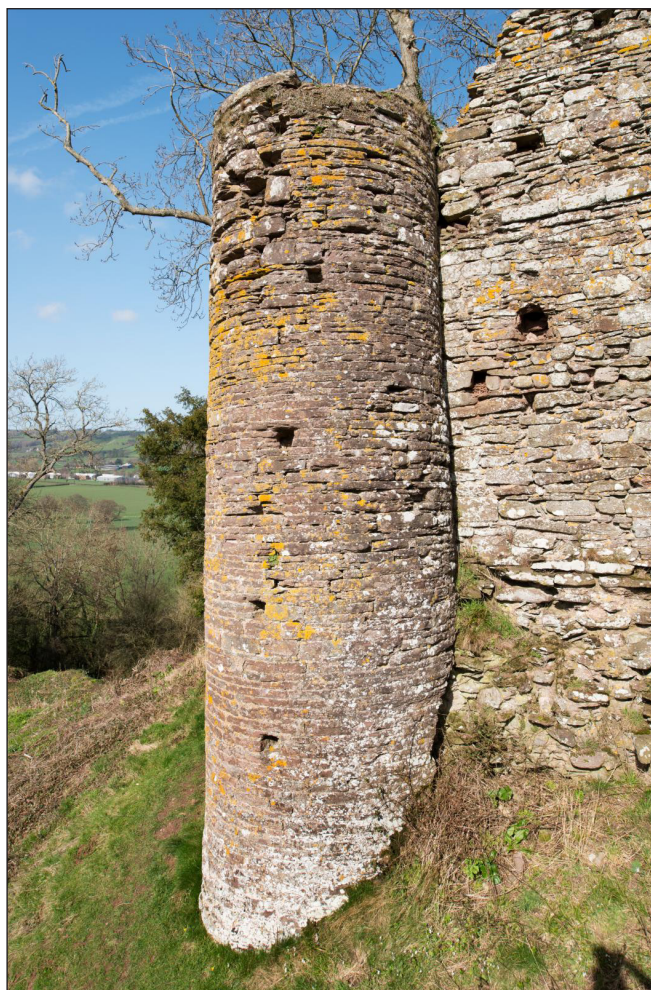
*Figure 15 Southwest drum tower built up against the walling of the earlier tower (DP195793).*

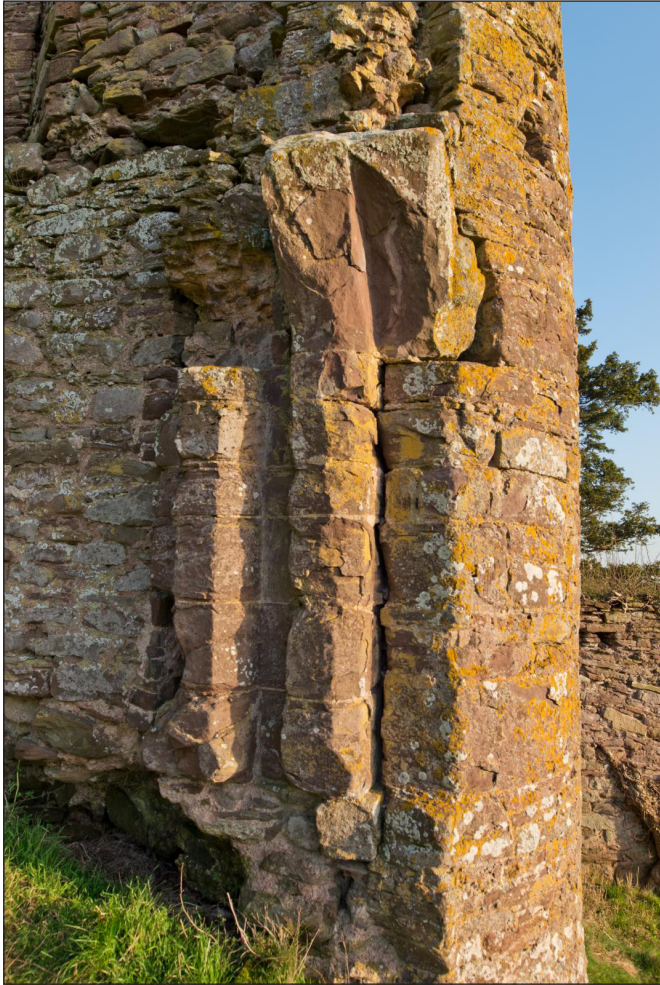
*Figure 16 Surviving section of arched head springing from southwest drum tower (DP195801).*

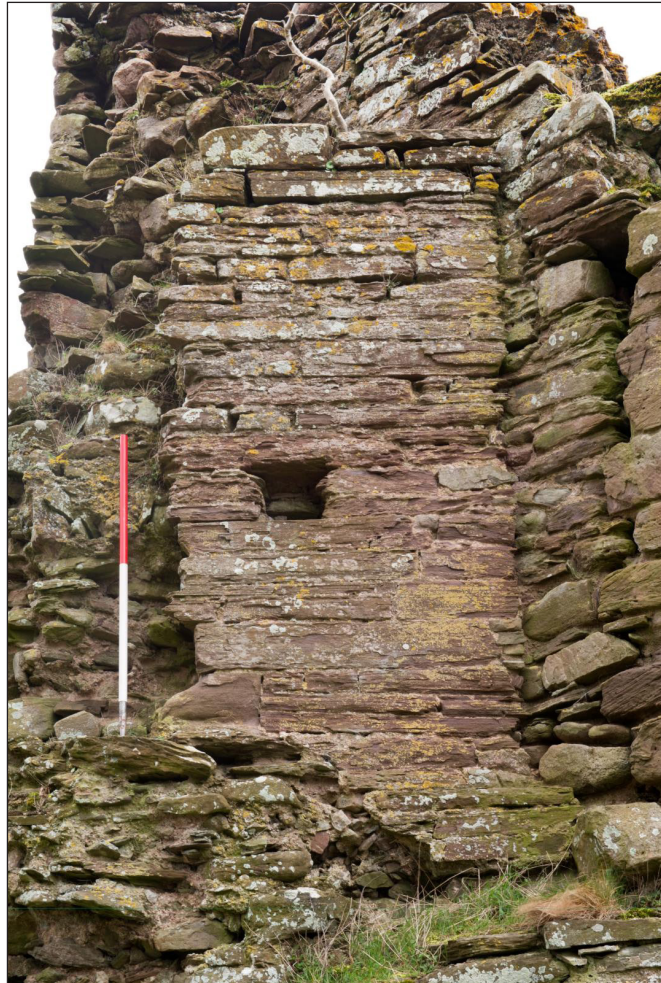
*Figure 17 Section of later walling built up against the original internal wall of the tower (DP195821).*

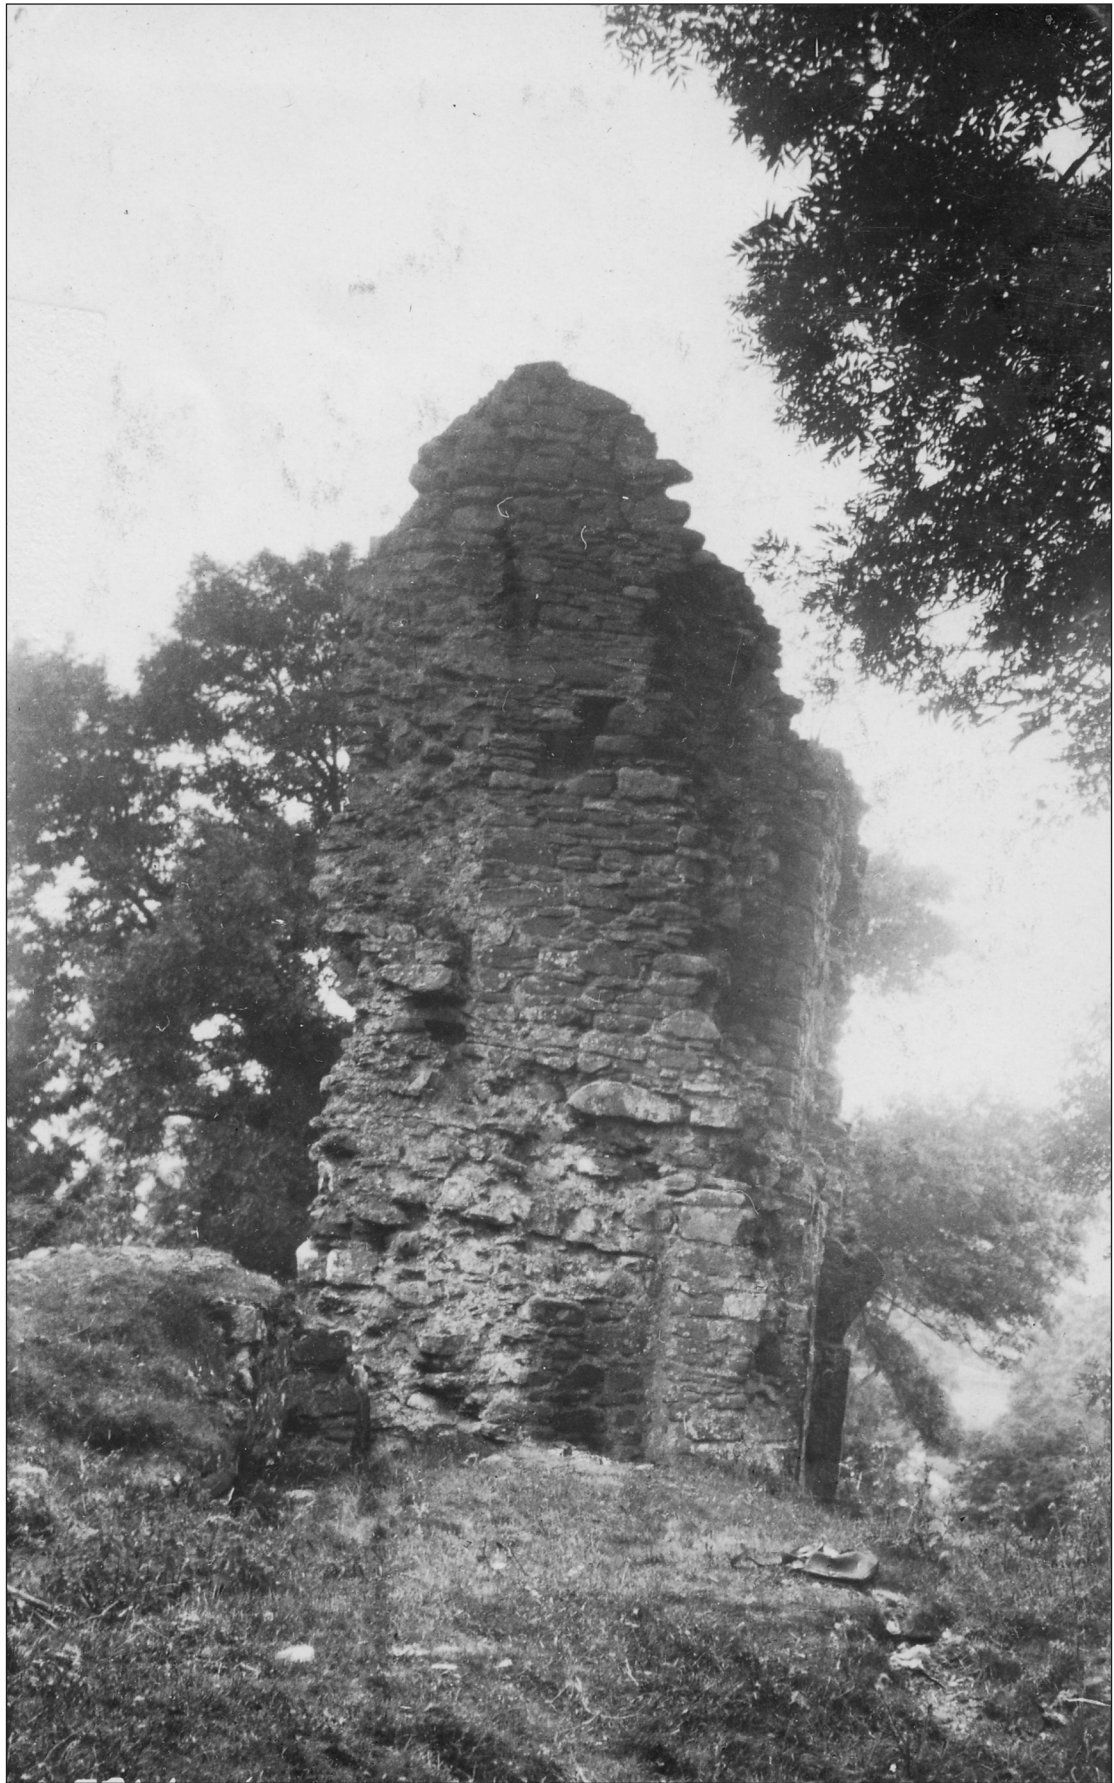
Figure 18 Photograph of the southwest corner of the tower taken by the RCHM in 1929 (HEA RCHM Inventory notes: Peterchurch Parish).

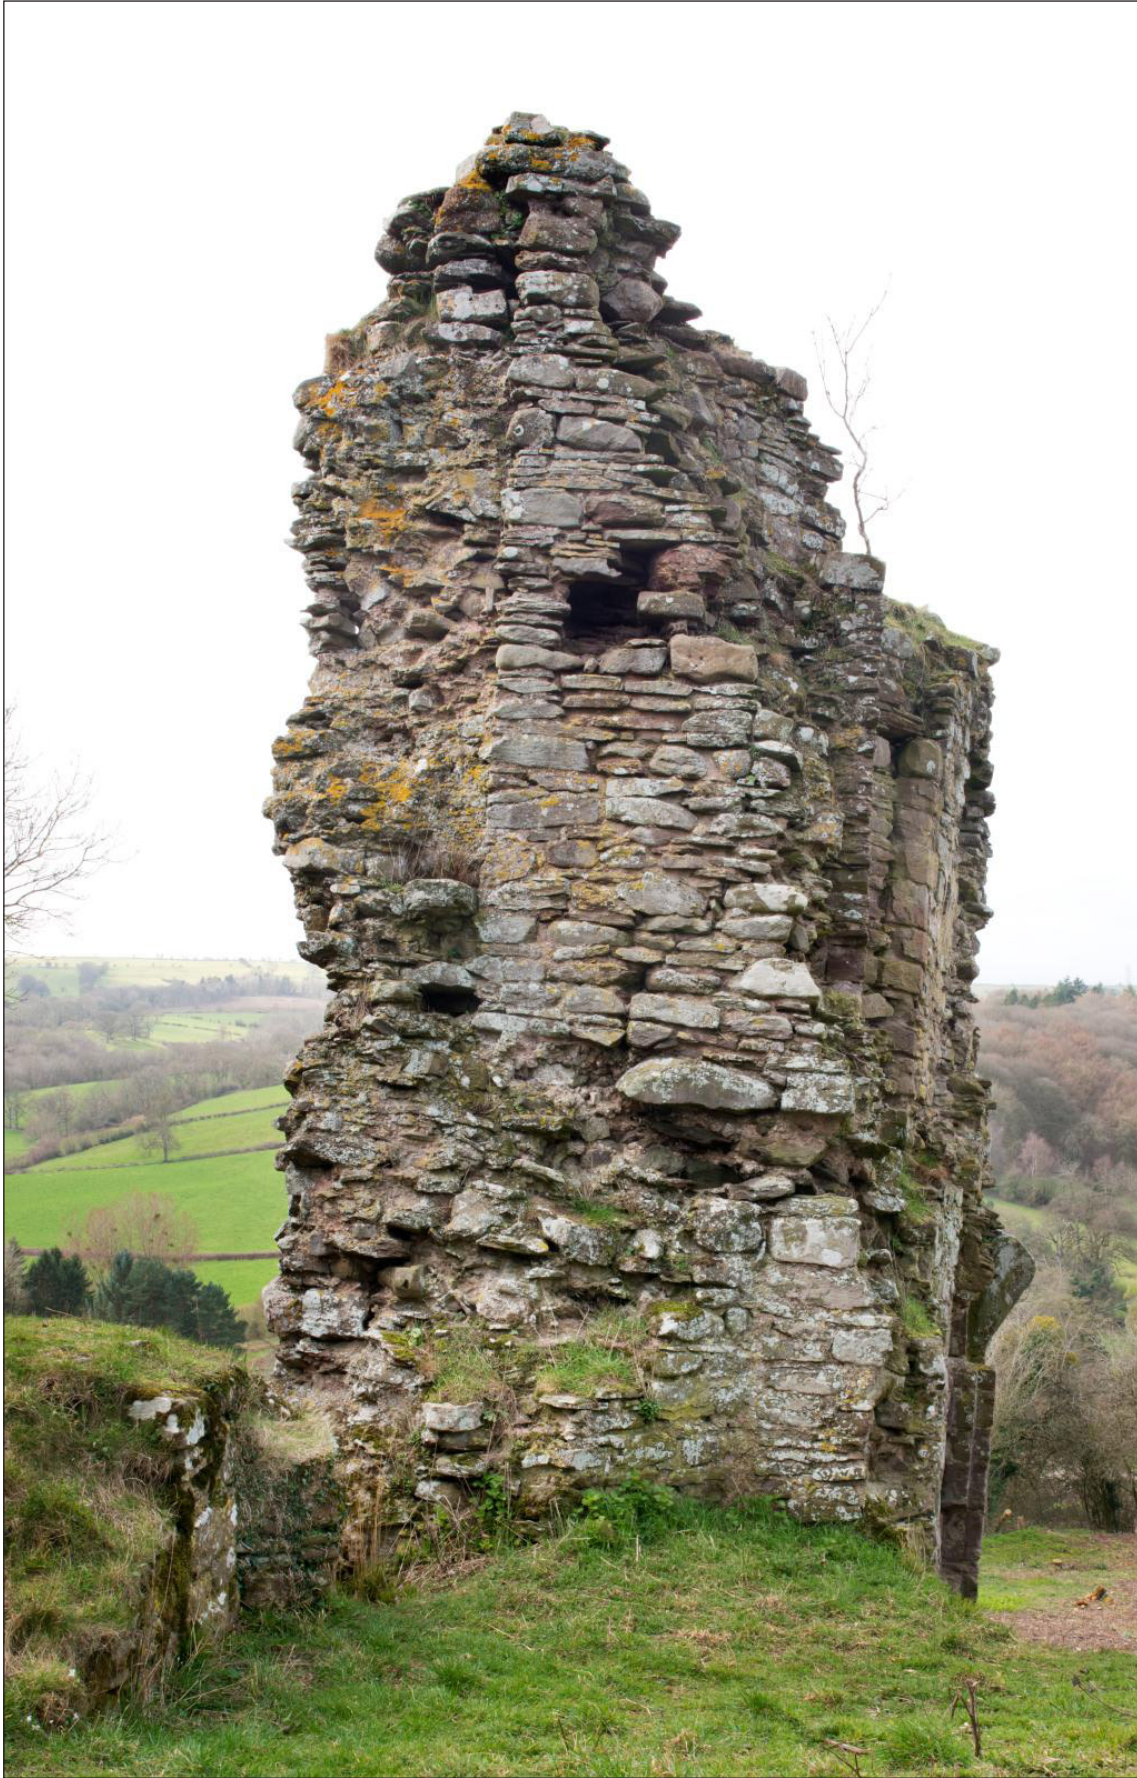
*Figure 19 Photograph of the southwest corner of the tower in 2017 (DP195814).*

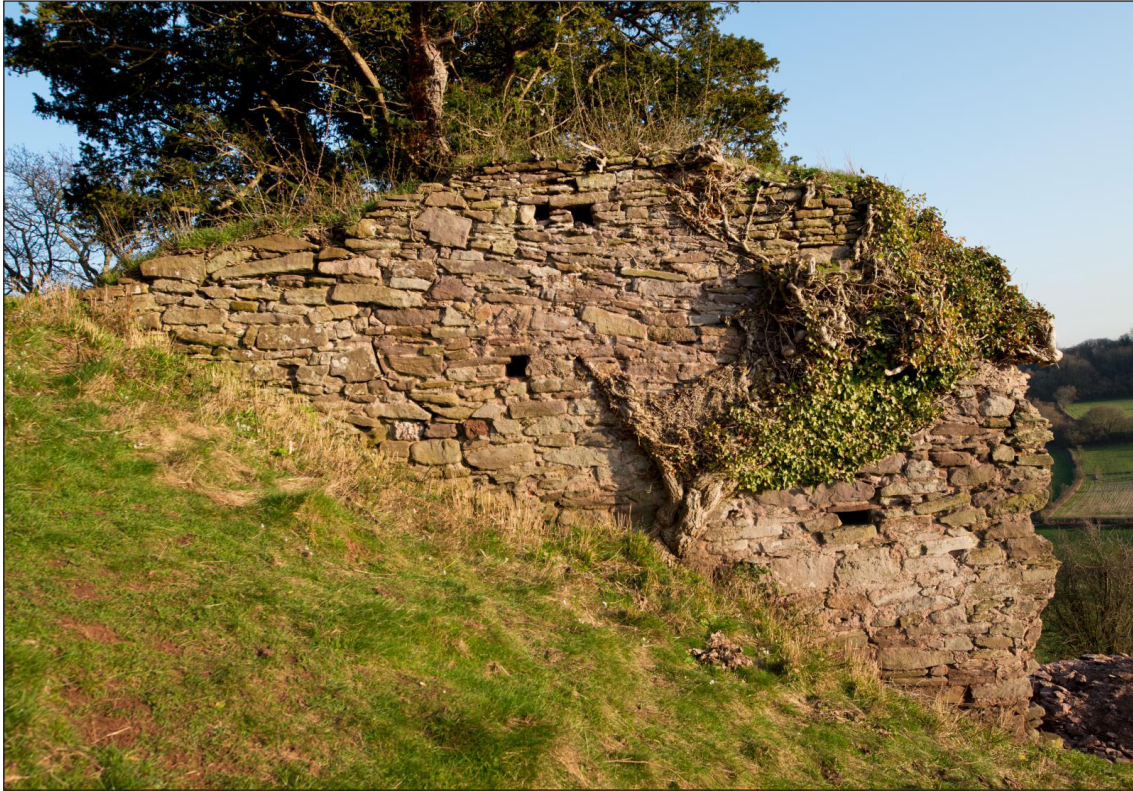
*Figure 20 South wing wall, view from the north (DP195800).*

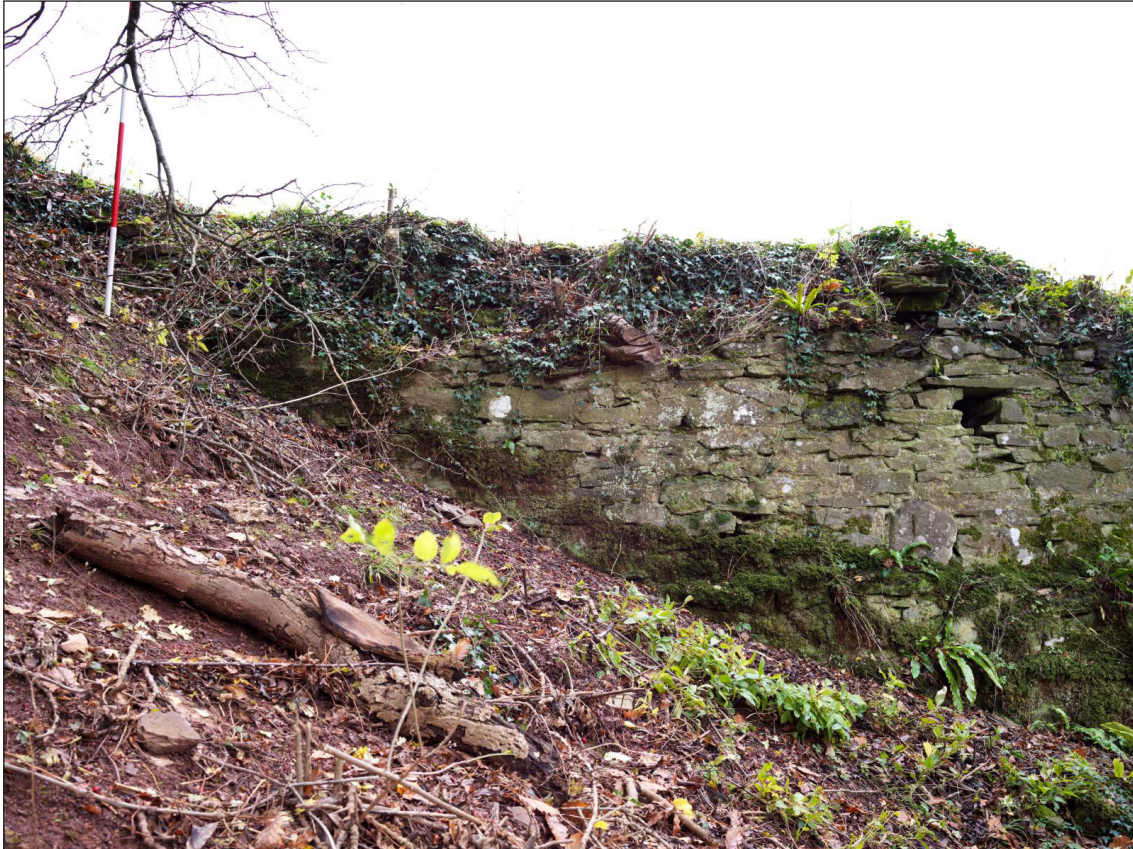
*Figure 21 North wing wall, view from south (DP195360).*

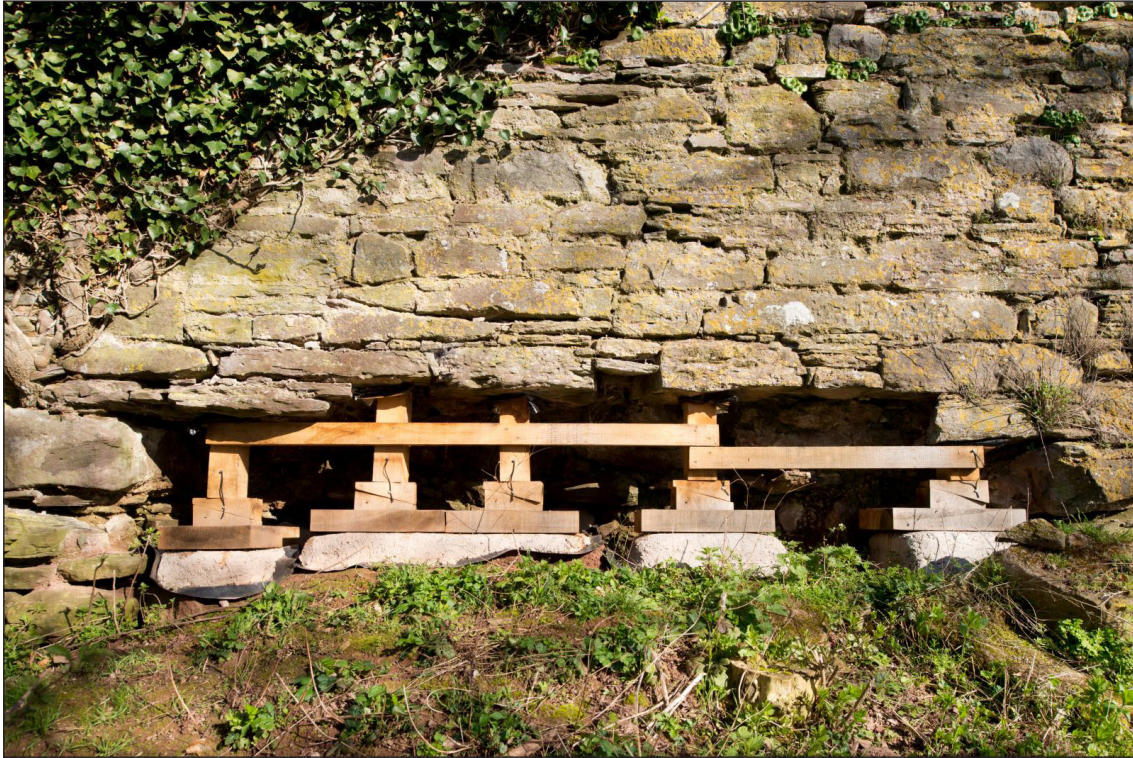
*Figure 22 Part of the west section of the south curtain wall, view from south (DP195786).*

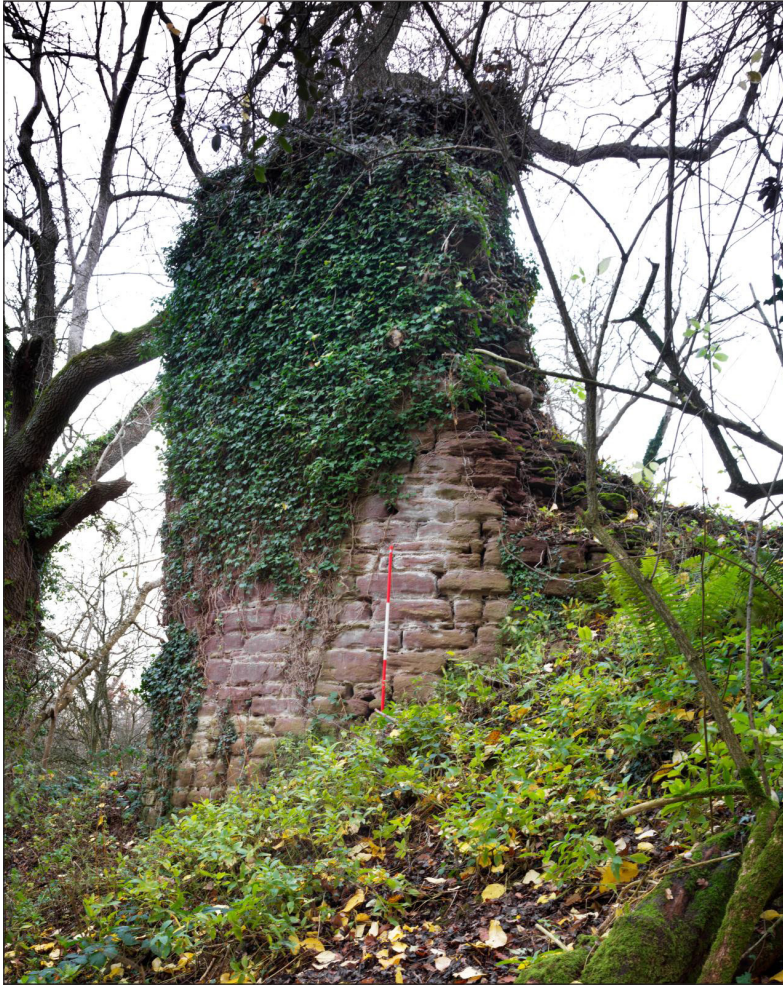
*Figure 24 North Tower, view from west (DP195357).*
