# Snodhill Castle, Peterchurch, Herefordshire: Archaeological, Architectural and Aerial Survey and Investigation

Research Report Series 076-2017

**SNODHILL CASTLE  
PETERCHURCH  
HEREFORDSHIRE**

**ARCHAEOLOGICAL, ARCHITECTURAL AND AERIAL  
INVESTIGATION AND SURVEY**

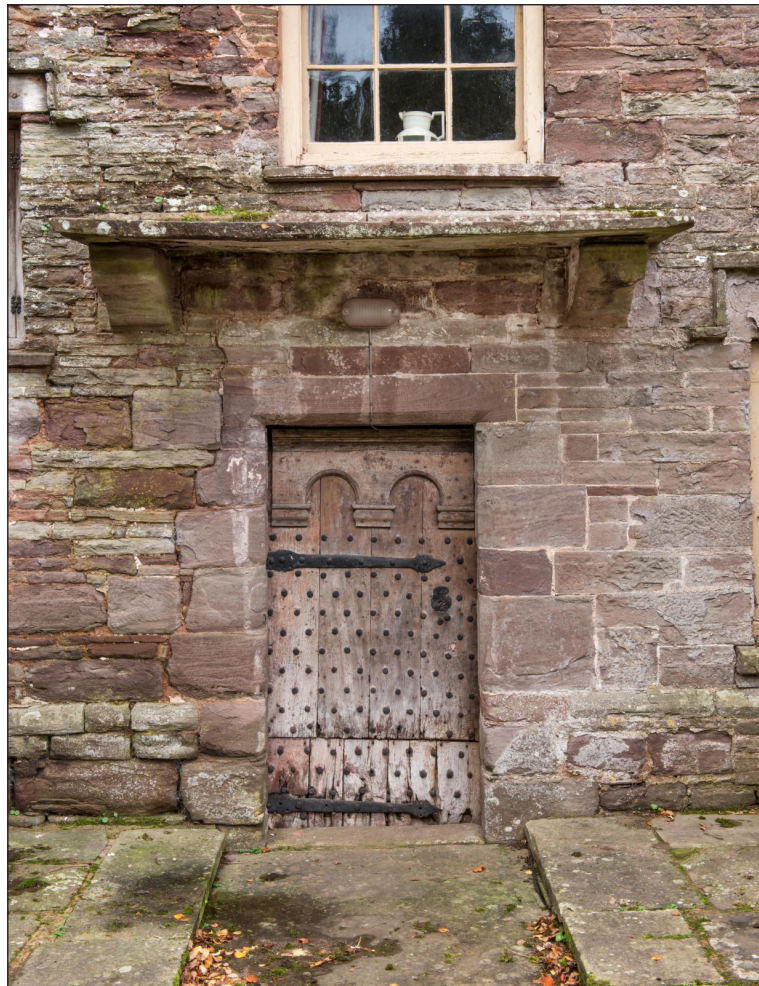
*Figure 25 Snodhill Court, main doorway, east elevation showing stone canopy (DP195439).*

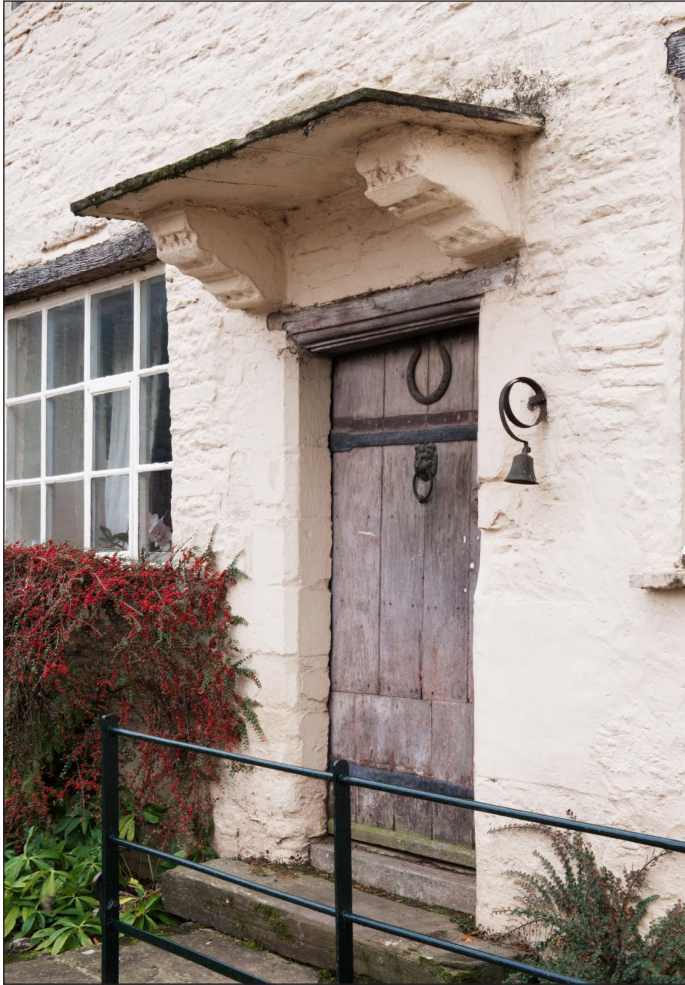
*Figure 26 Snodhill Court, doorway to north elevation (DP195444).*

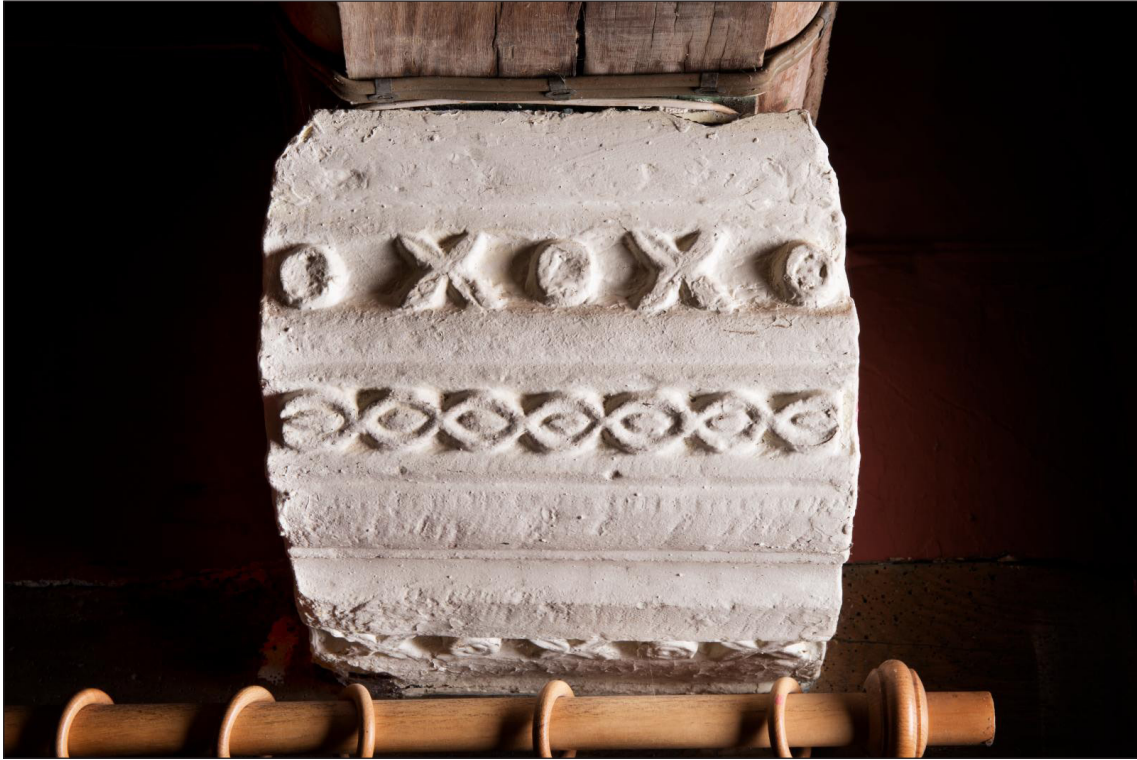
*Figure 27 Snodhill Court, one of the corbels supporting the eastern end of the cross beams in the hall (DP195435).*

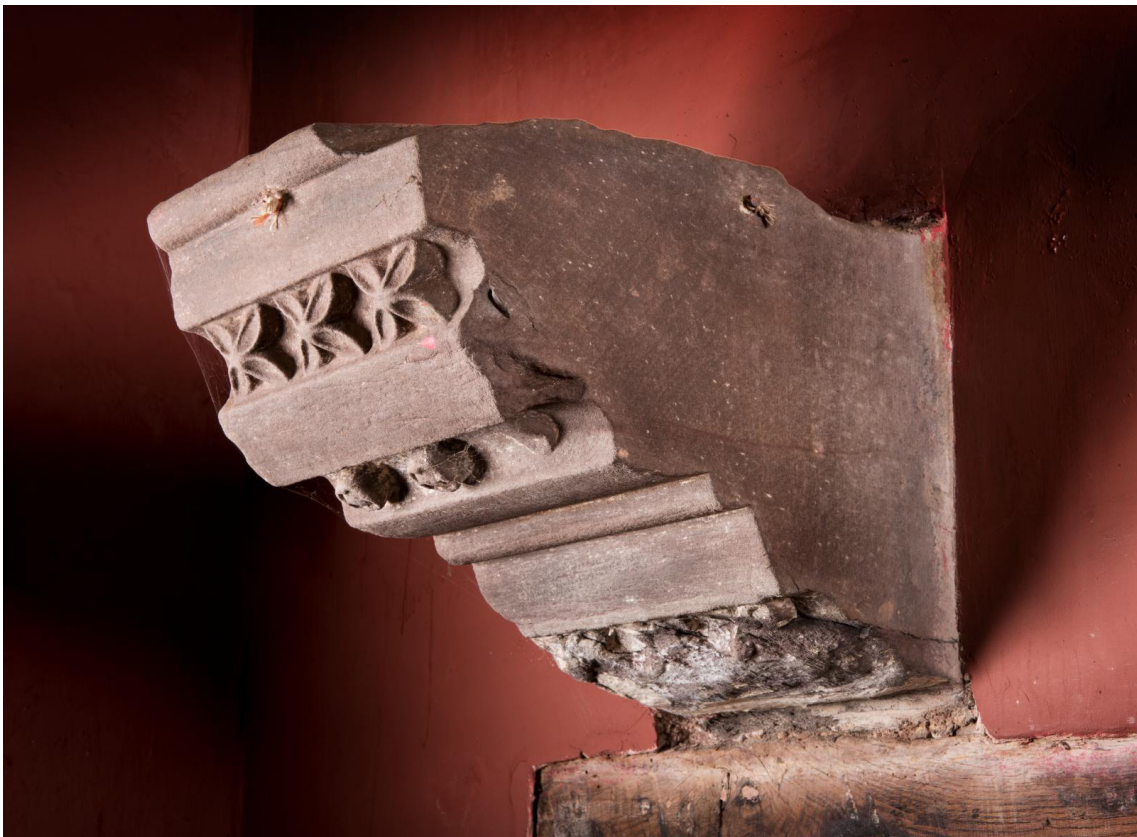
*Figure 28 Snodhill Court, corbel over the fireplace in the west elevation of the hall (DP195428).*

slightly sunken creating a foliate form. The central band takes the form of a type of ball-flower decoration, that is a central ball held by four 'petals' or lobes. However, this does not take the usual ball flower form, which is typically a more pronounced round shape, and with a greater articulation between the central ball and the outer lobes (see for example Hereford Cathedral North Transept and upper sections of the tower). The lowest band is considerably damaged, even on the internal example, but may have had the same quatrefoil decoration as in the upper band.

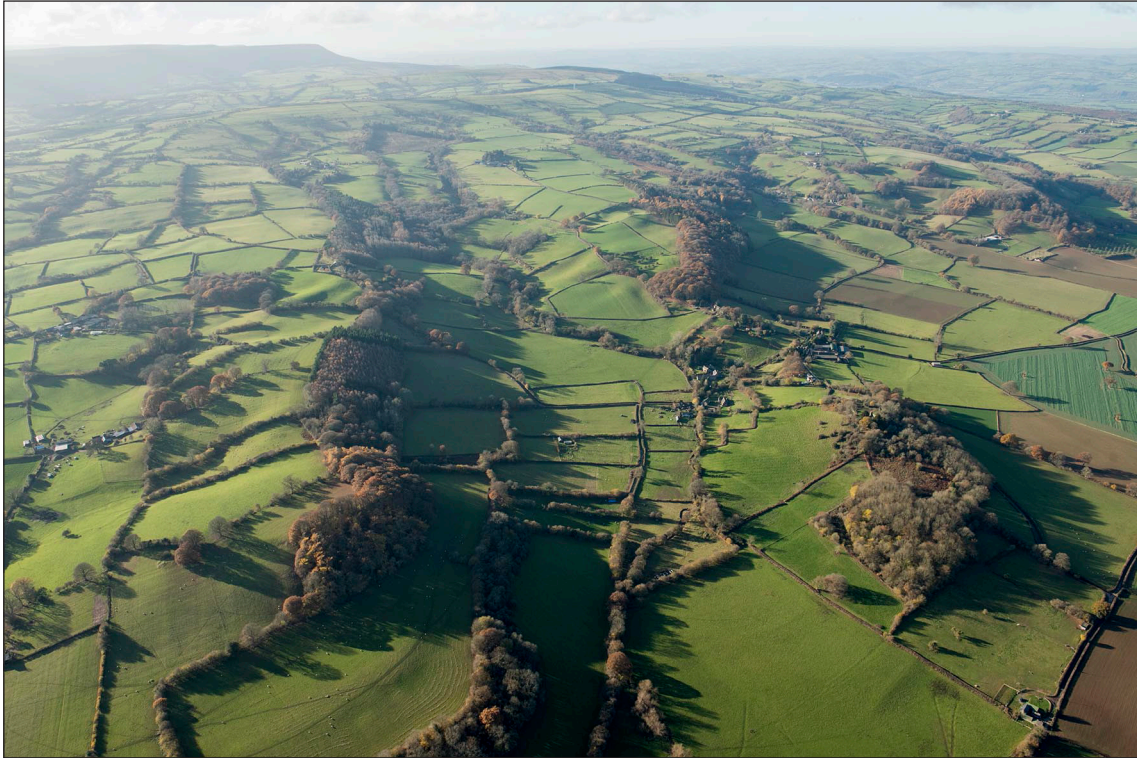
*Figure 29 Looking west across the former manor of Snodhill to the Black Mountains in the Brecon Beacons National Park. Snodhill Castle lies in trees in the bottom right-hand corner and the park occupies much of the centre of this picture. HEA 29993\_008 25-NOV-2016*

The terrain around the castle rises steadily from the flood plain of the Dore to the ridge of Vagar Hill at 430m which runs north-west to south-east and marks the south-western extent of the manor and deer park of Snodhill (Figure 29). Beyond this the undulating terrain continues to rise towards the distant Black Mountains across the border into Wales. The immediate landscape of Snodhill forms a sloping elongated bowl sub-divided by a number of roughly parallel streams which rise high on the north-eastern flanks of Vagar Hill, flowing north-eastwards in the direction of the River Dore (Figure 30). Within this bowl lies the expanse of the former medieval deer park, the western end of which is still defined by the fragmentary remains of an enclosing park pale. The pale survives in parts in the upper (western) of the park, but there are no physical remains or cartographic evidence of the lower reaches of the deer park in the vicinity of the castle. Whether the castle lay within or outside its deer park has yet to be ascertained (see below).

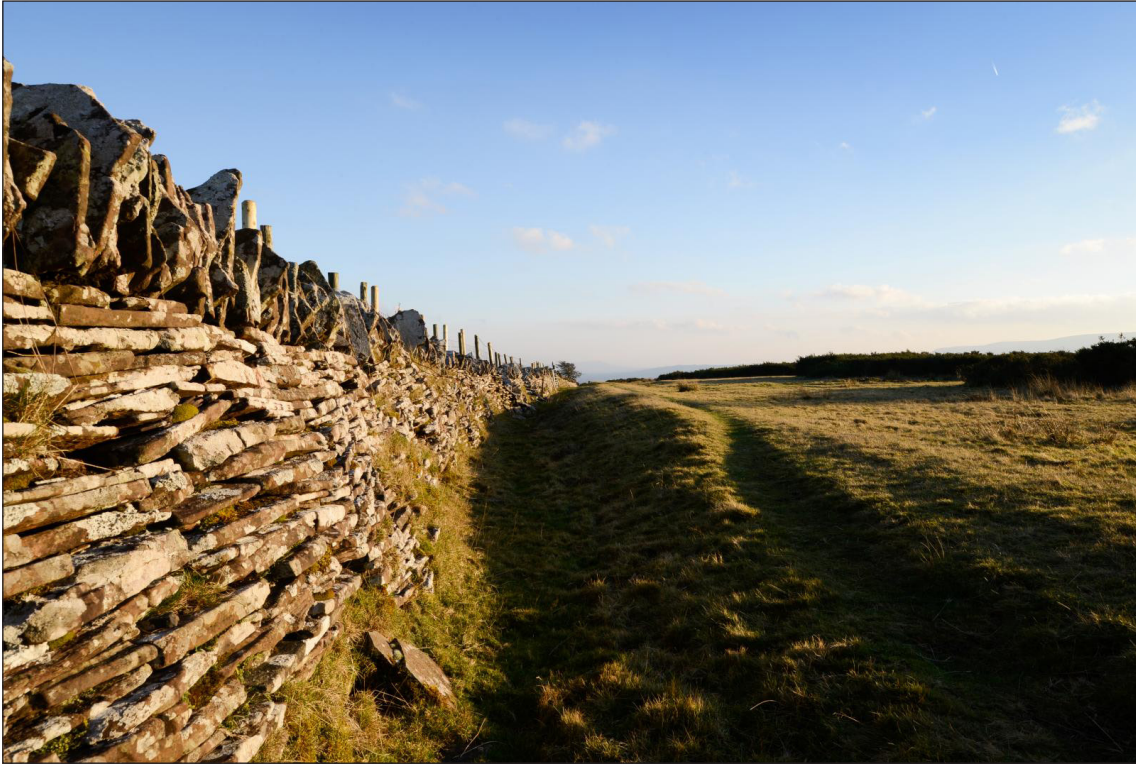
*Figure 33 Snodhill Park pale on Vagar Hill (exterior view) with the much-reduced and filled outer ditch and dry-stone wall (DP195848).*

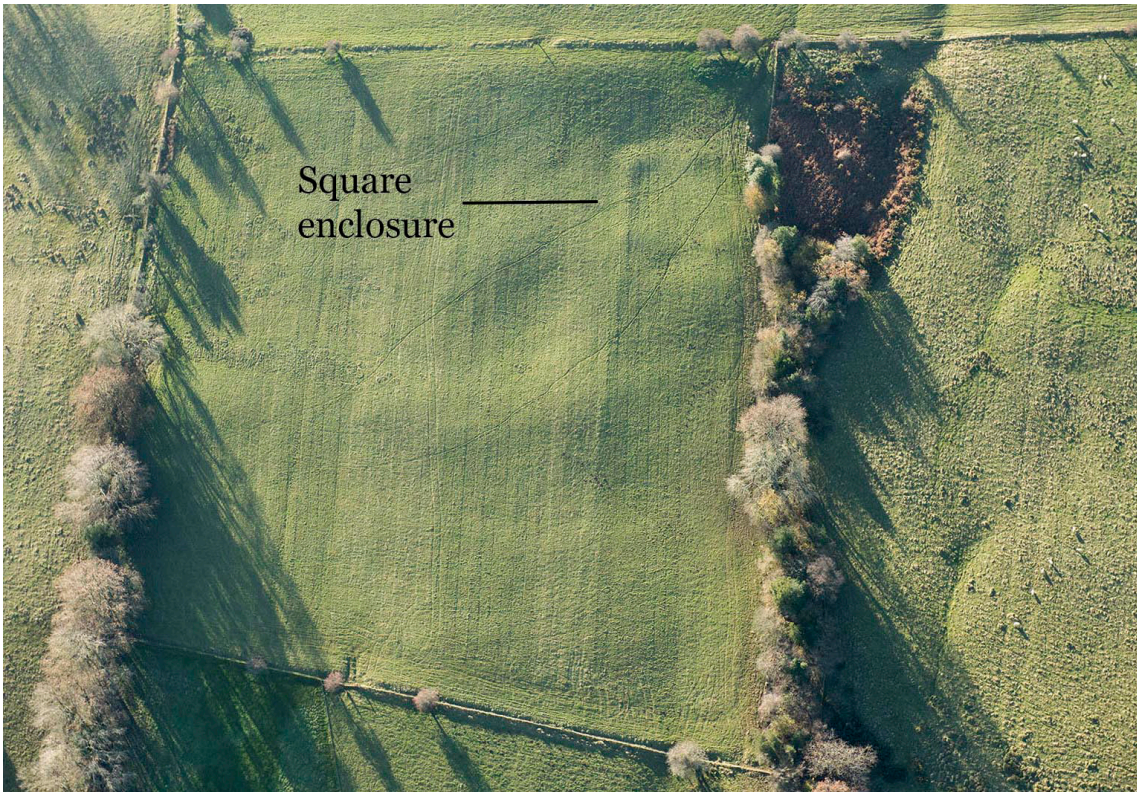
Figure 35 Aerial photograph showing the slight earthworks of a square embanked enclosure within Snodhill Park. HEA 29993\_010 25-NOV-2016

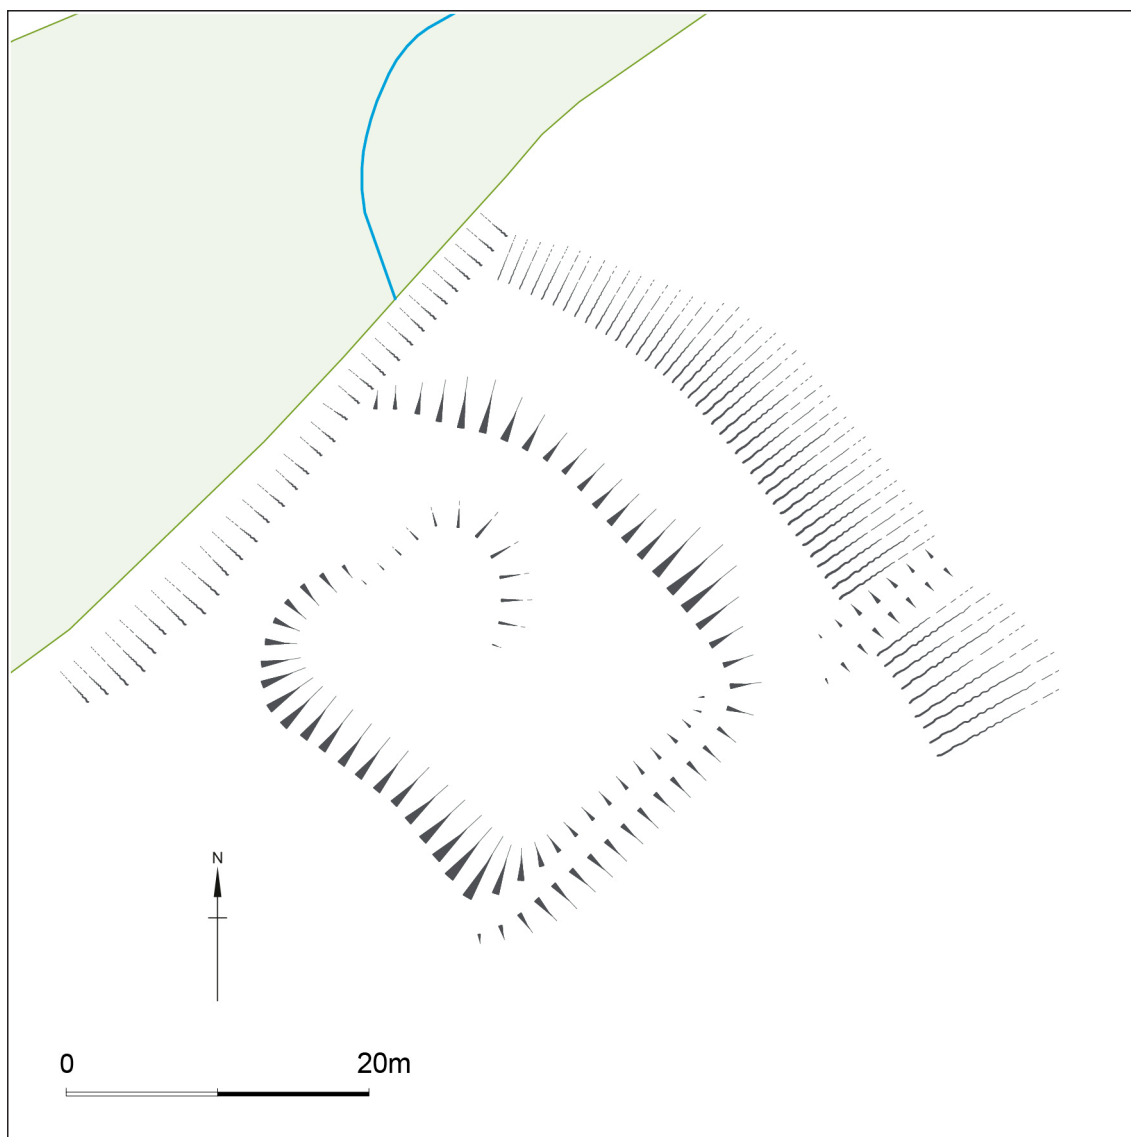
Figure 37 Survey of the new enclosure west of Pen-y-Park.

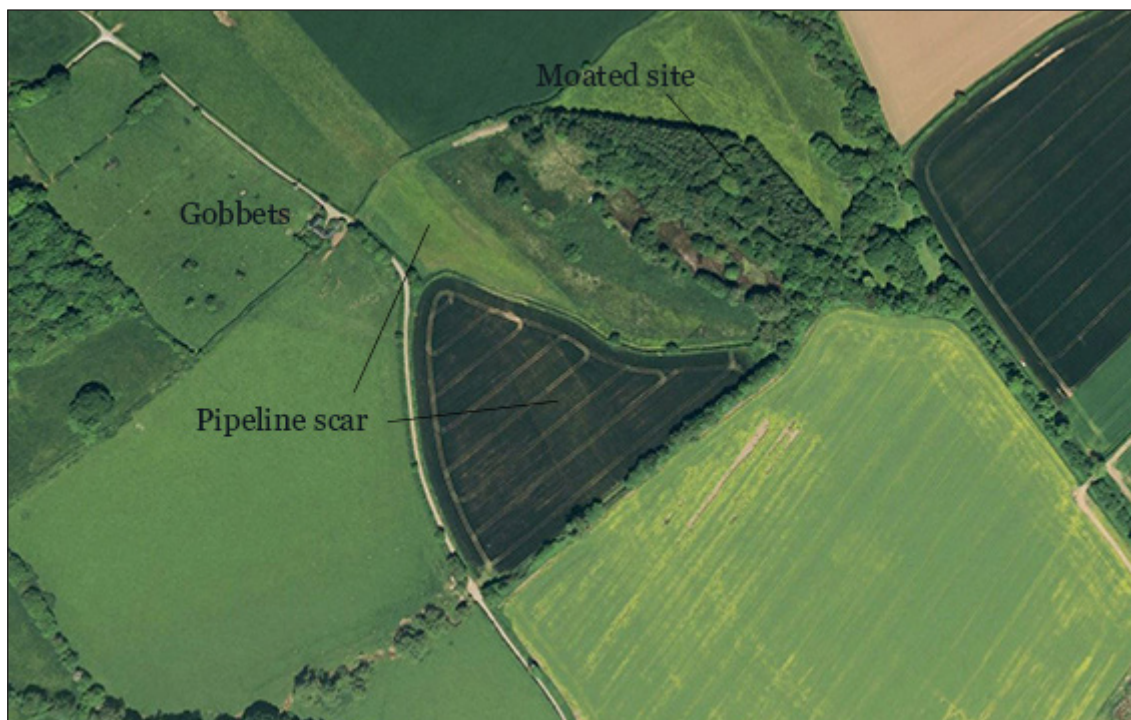
*Figure 42 Google Earth image dated 24/5/2009 showing the pipeline scar – a band of different coloured vegetation caused by the gas pipeline cut passing between The Gobbets and the moated site. Google Earth accessed 16/08/2017.*
