The History of Ewyas Lacy

Title: Digital Archive: Royal Commission on Ancient and Historical Monuments - Photographs of original survey particulars, Part 1 of 13

Part 1: Craswall and Michaelchurch Escley

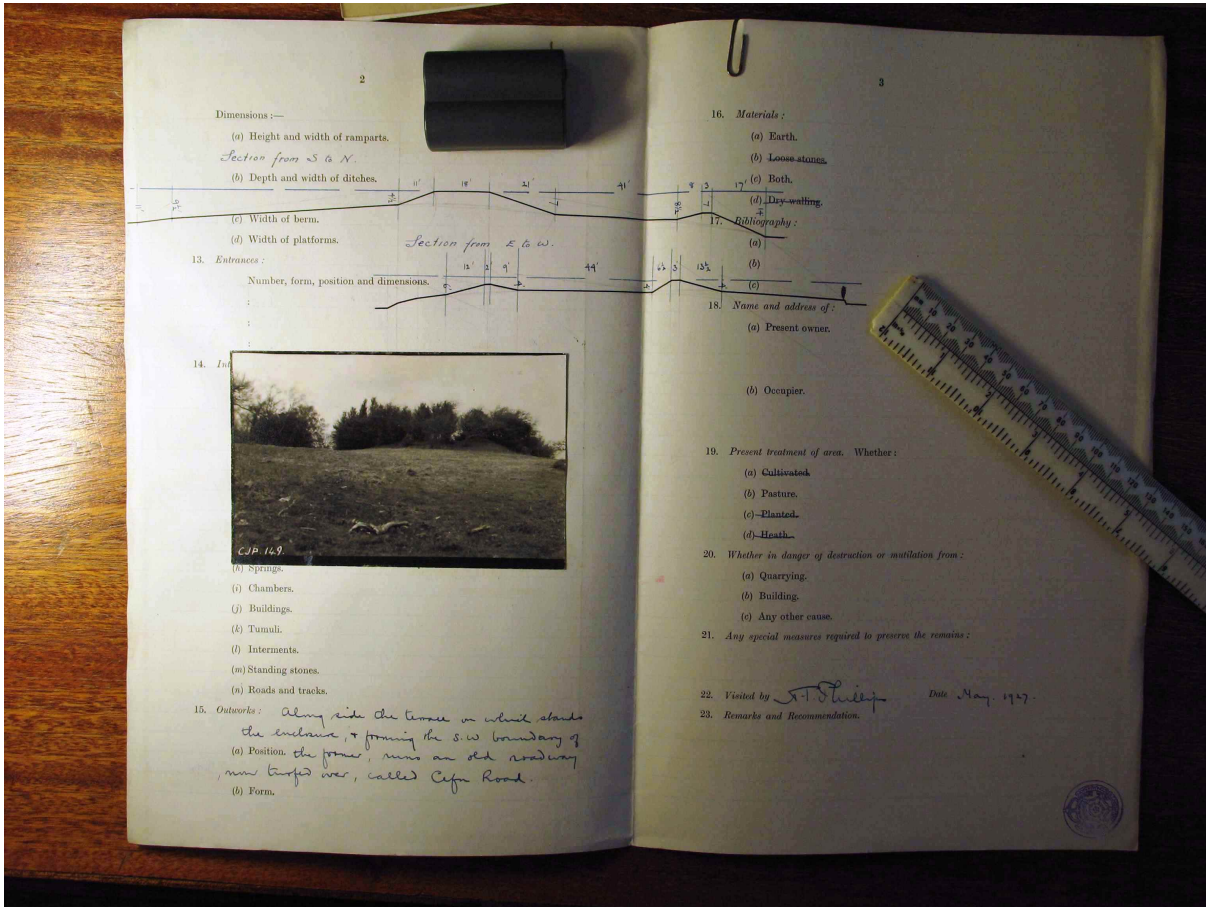
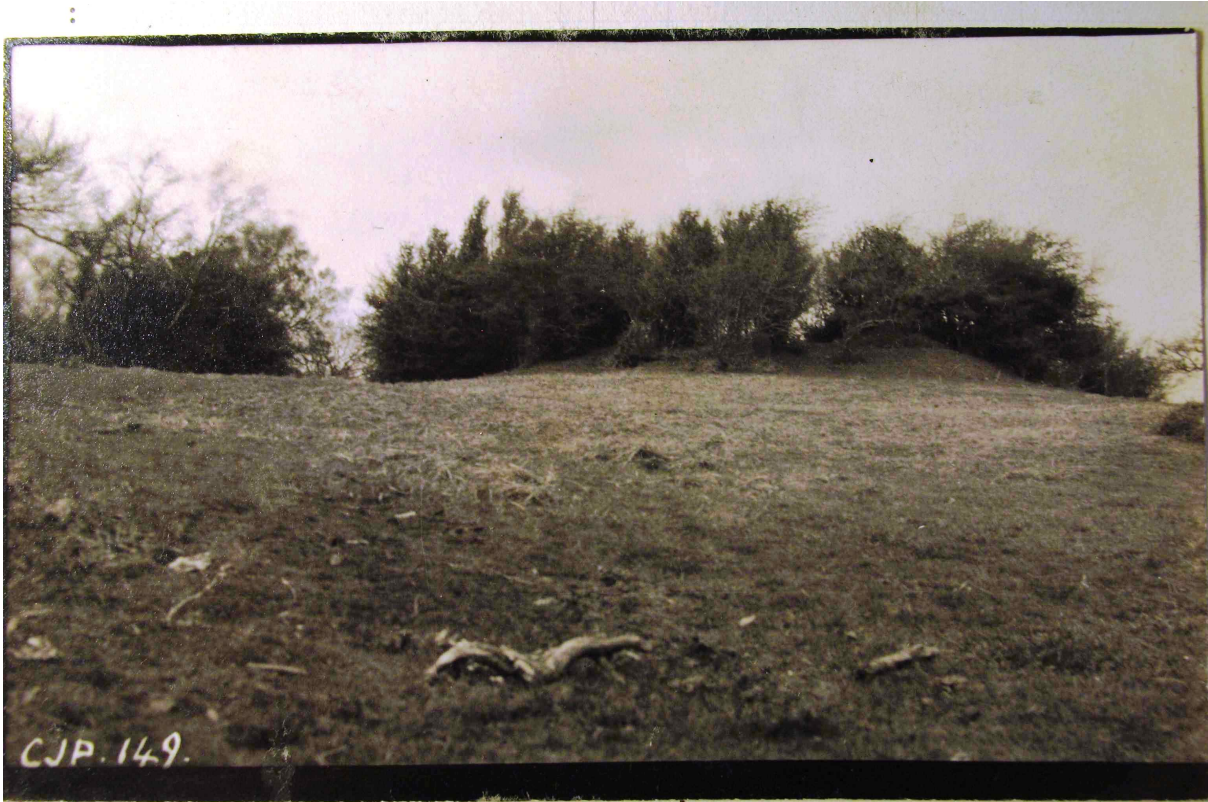
12. Arrangements :
 - (a) Ramparts. A curvilinear oval shaped enclosure surrounded by a rampart which at the
 - (b) Ditches. South end has a broad flat top. This enclosure stands on a rough

- (c) Berms. terrace or platform of an irregular oval
 - (d) Platforms. shape, the scarp of same running into , being incorporated into, the rampart at its northern extremity. It is difficult to imagine the exact purpose of this work which, though quite possibly a defensive post of some sort, is certainly not as its name would imply - a camp.

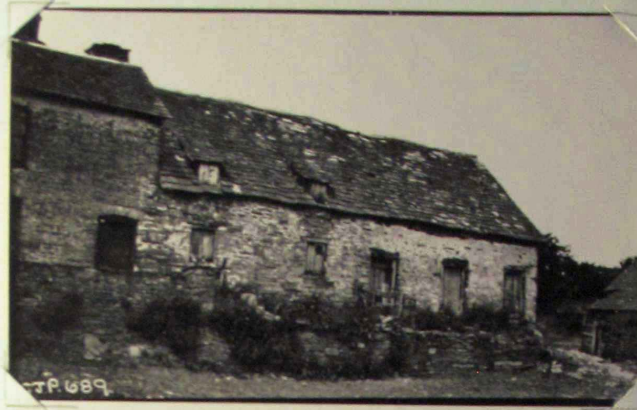
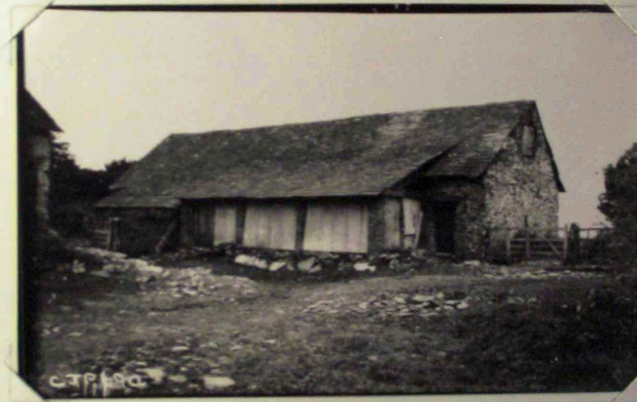
There is a small doorway (modern door) at each end of S.W. side. Internally it is divided into 5 bays by four cross-tusses, the two end bays being 12ft wide the others 10ft centre to centre.

*Build probably late in 15th c.
Condition poor.*

8. Condition: *almost ruins.*

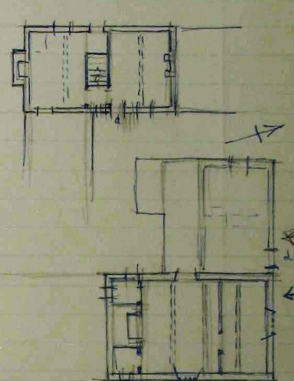
3. Caciron Historical development (with dates and small sketch plan).
The date 1681 on the front is probably that of the house but it has been much altered in later repairs.
Lower Glasrosen. Is probably of the 17th century but now empty & the place locked up.

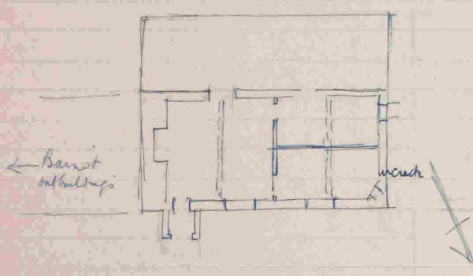
3. Historical development (with dates and small sketch plan).
*A 17th century house much altered. The N. front has been heightened the
pitch of the roof being flattened there by*

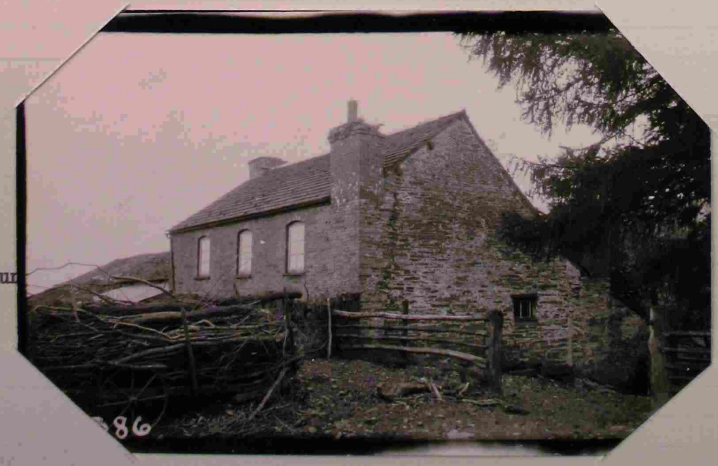
6. Ground plan

5. Elevations: (Beginning with the main front, and mentioning, in the following order:—(a) Walls; (b) Gables; (c) Doors; (d) Windows; (e) Chimneys; (f) Rainwater heads and pipes.)
*A front modern stone walls & windows with red brick surrounds & a modern Welsh gable.
The E & W end walls show the original gable lines before the front gable
was heightened. Square stone chimney stack over the E gable.
At the back (S.) are low additions and E of the house a long low
outbuilding.*

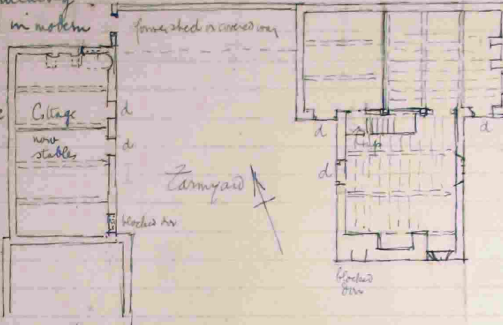
The farmhouse is an early 17th century building of T shaped plan. It has been altered in modern times & some of its old oak removed. A rectangular building W of the house was originally a dwelling house of the 16th century.

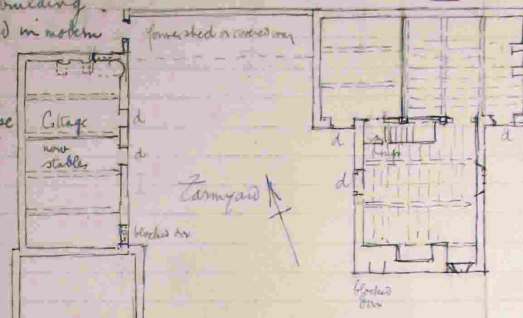
3. Historical development (with dates and small sketch plan).
The farmhouse is an early 17th century building of T-shaped plan. It has been altered in modern times & some of its old oak removed. A rectangular building W of the house now stables was originally a dwelling house of the 16th century.
