The History of Ewyas Lacy

Title: Digital Archive: Royal Commission on Ancient and Historical Monuments - Photographs of original survey particulars, Part 10 of 13

Part 10: Longtown

ELSG Ref RCAHM Records: Longtown

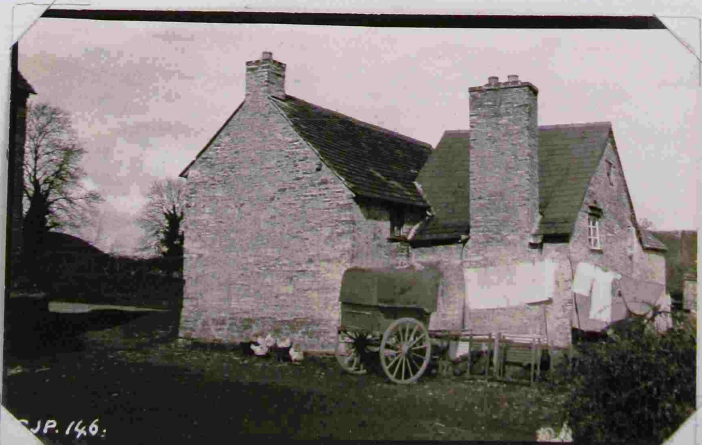
3. **Historical development** (with dates and small sketch plan).
A 17th c. house which has been so much re-modelled & re-roofed during the 18th c. as to make it difficult to trace original plan. It is however probable that the shop room & gable are 17th c. as also the projection to the E—though a few years later—while the stone room

4. **Special features** (if any). *on its S side was probably added early in 18th c.*

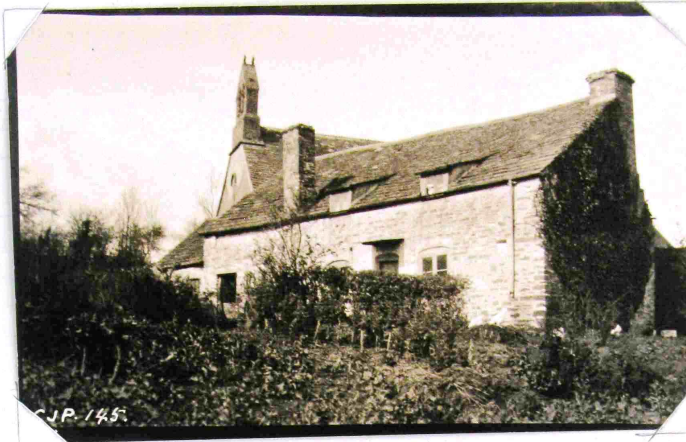
*In room at S angle are 3 exposed chamfered beams, one being stop chamfered.
 The ceiling joists are exposed in the passages.*

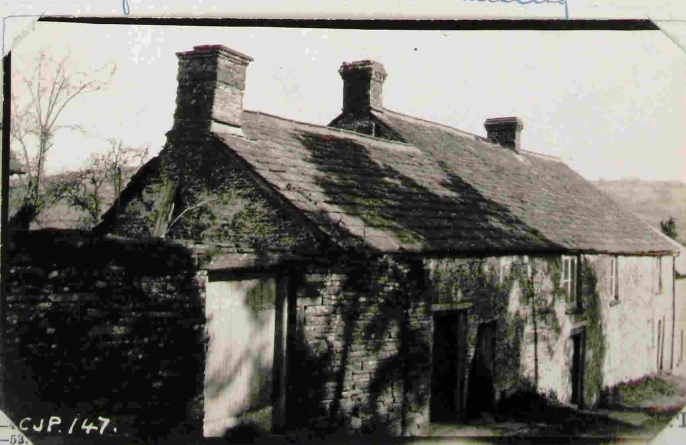
3. **Historical development** (with dates and small sketch plan).
A 17th c. house. Slight re-modelling has been done in 18th c. modern times.

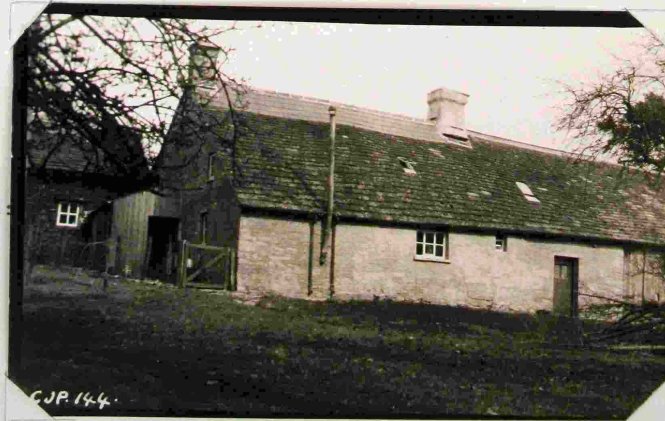
1. Name and situation of Monument (with owner's Name and Address). Pen-y-dre
90 yds. W. of church.
2. General appearance: (a) No. of storeys. 2. (1 gable on W side)
(b) Building materials. Rubble stone
(c) Roofs. Stone slates. (some mod. slate repair)

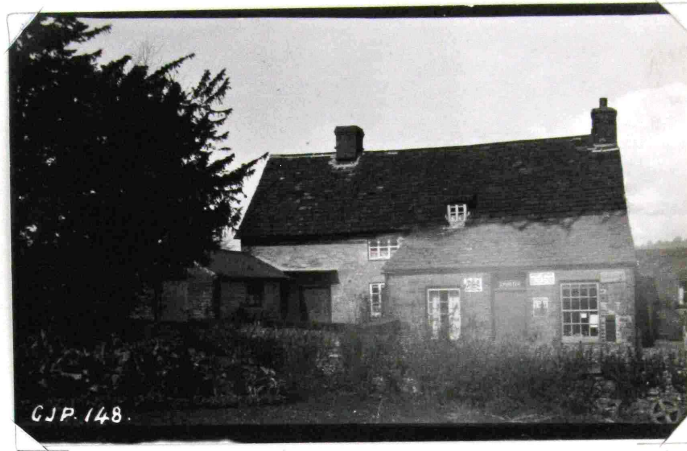
Ceilings of ground floor rooms have exposed changed beams & there are some exposed joists.

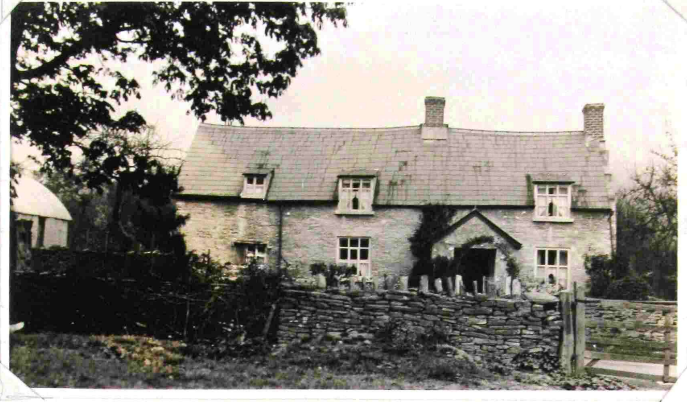
On ground floor are 2 17th c. battened doors one plain & the other has moulded planks.

On 1st floor is one plain battened door.
