Title: Digital Archive: Royal Commission on Ancient and Historical Monuments - Photographs of original survey particulars, Part 11 of 13

Part 11: Longtown

ELSG Ref RCAHM Records: Longtown

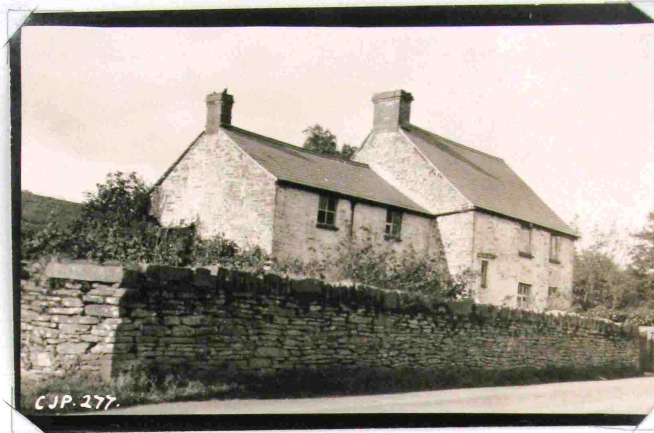
Between the two ground floor rooms is a partition the part pulled on stop chamfered as also on cills & head with wood panels.

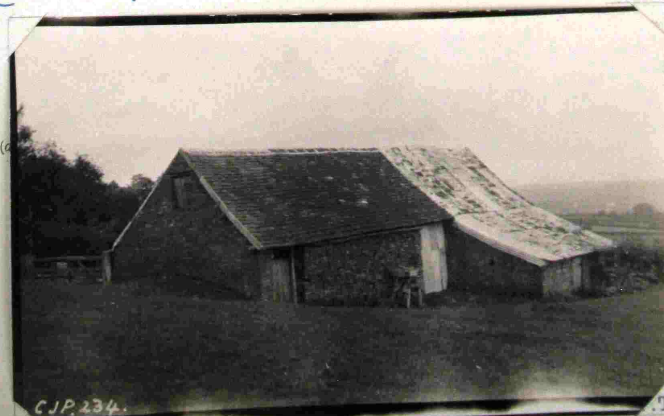
A 17th c. barn. In modern times the S.W end has been rebuilt as also has the S.E. when timber framing has been replaced by a rubble stone wall.

S.W. Elev. Gabled. Re-built.

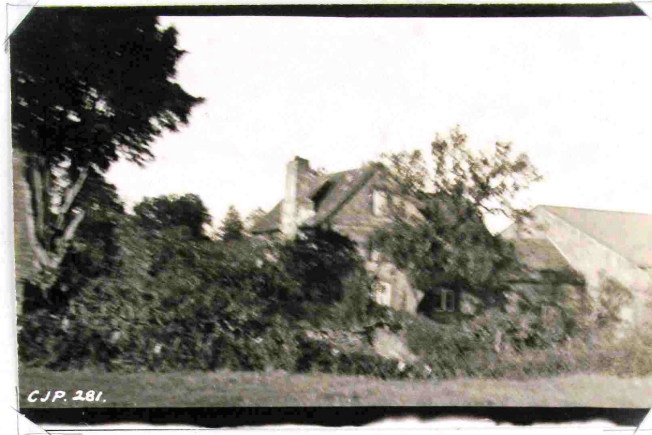
In W. wall of living room is a stop chamfered door frame.

Ceilings of ground floor rooms have stop chamfered beams exposed except to later wing. On 1st floor are some exposed stop chamfered beams in ceilings.

W. wing has turrets of type $\Delta\Delta$

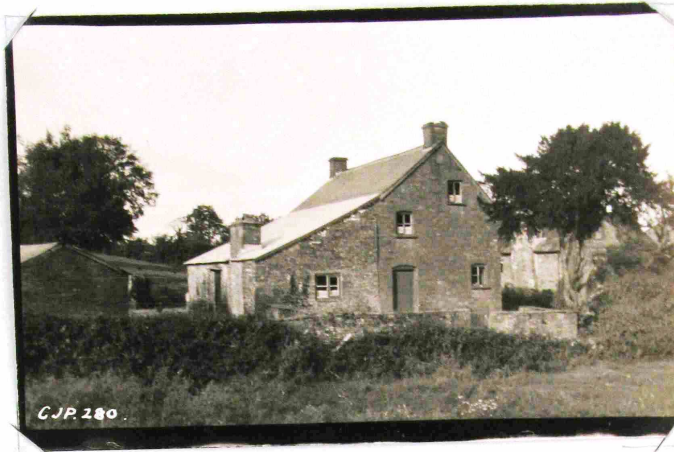
Doorway between two rooms has a stop chamfered door frame.

Ceilings of ground floor rooms have exposed stop chamfered beams & exposed ceiling joists.

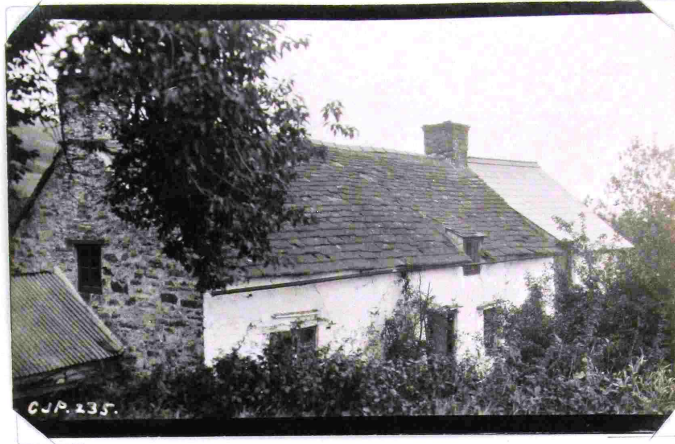
Ceilings of ground floor rooms have exposed ^{step} chamfered beams & the joints are exposed in the more easterly room.

Between the two rooms the spaces between timber posts of partition are filled with wood panels (now covered with wall-paper).

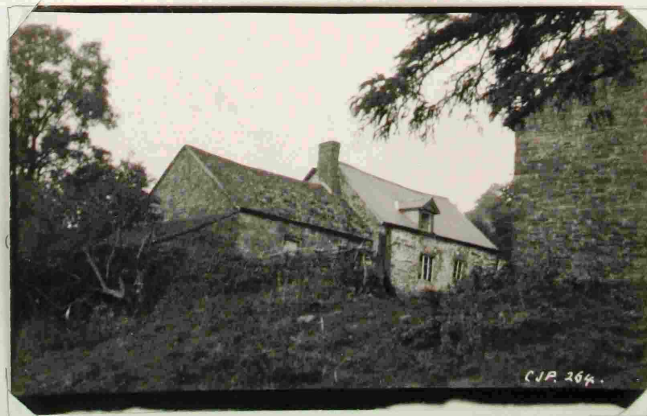
W. Elev. Gabled. Mostly concealed by re-built portion of house.

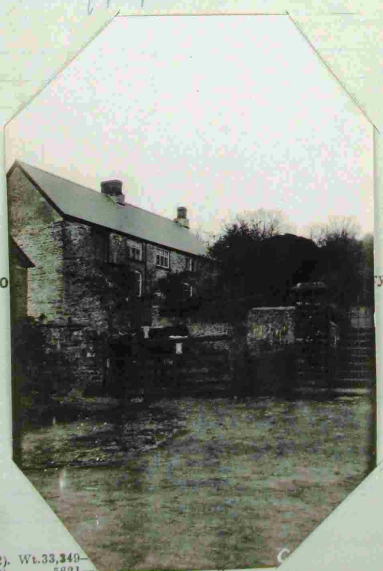
S.E. front. Walls of stone rubble with modern door and windows. At the S.W. end is an external stone stair leading up to a loft forming the S.W. room of the 1st floor. The central chimney and that at the N.E. end are plain rectangular stacks of old stone on the S.E. front but of modern brick repair on the N.W. sides. The S.W. end is a blank stone gable, and at the N.E. end the chimney projects.
