The History of Ewyas Lacy

Title: Digital Archive: Royal Commission on Ancient and Historical Monuments - Photographs of original survey particulars, Part 12 of 13

Part 12: Longtown

RECORD CARD FOR SECULAR MONUMENTS.

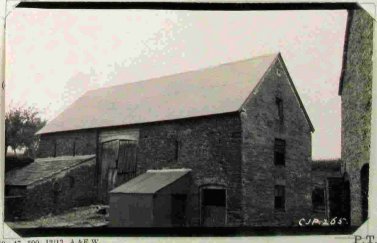
3. Historical development (with dates and small sketch plan).
A late 17th c. barn. Modern lean-to roof addition has been built against N & S sides.

S. Elev. Double doors with old heavy square joint segmental head to frame. 3 slit windows.
N. Elev. Uniform with S. elevation.

W. Elev. Gabled. Blocked window on ground floor. Square opening in gable vault above same.

E. Elev. Gabled. On ground level on slight casement frame formerly subdivided diamond mullioned window. In top of gable is a 3 light diamond mullioned window frame with mullion missing.

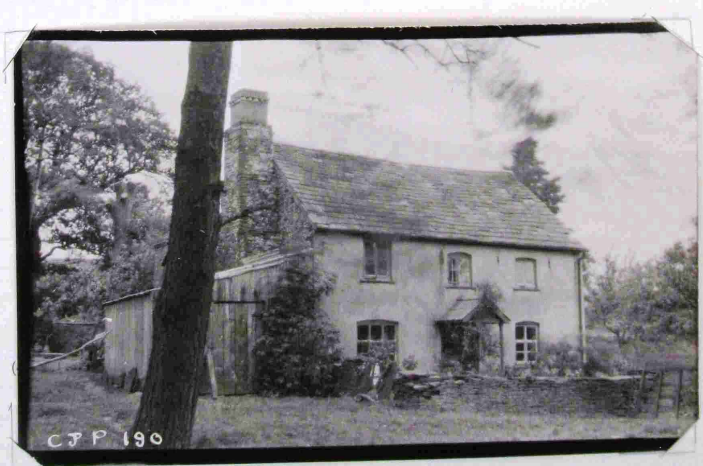
3. Historical development (with dates and small sketch plan).
Built c. 1700. In modern times a lean-to has been built along N. side. An addition built on against W end.

5. Elevations: (Beginning with the main front, and mentioning, in the following order:—(a) Walls; (b) Gables; (c) Doors; (d) Windows; (e) Chimneys; (f) Rainwater heads and pipes.)
The elevations are largely concealed & modernised. It is gabled at E & W ends & at latter end is a square stone chimney stack with modern brick shaft.

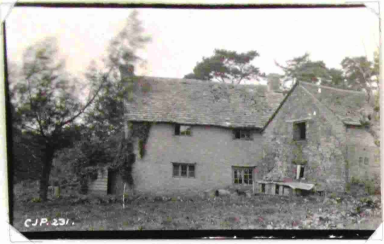
Staircase has solid oak bank steps.

The roof is a plain roof with 7 trusses the two central ones being of type Δ while the two outer ones are minus Δ the trusses.

Ceilings of ground floor rooms have exposed stop chamfered beams while in the two smaller rooms the ceiling joists are also exposed.

Between the two rooms on ground floor is a timber framed partition with stop chamfered head, posts built round panel infilling.

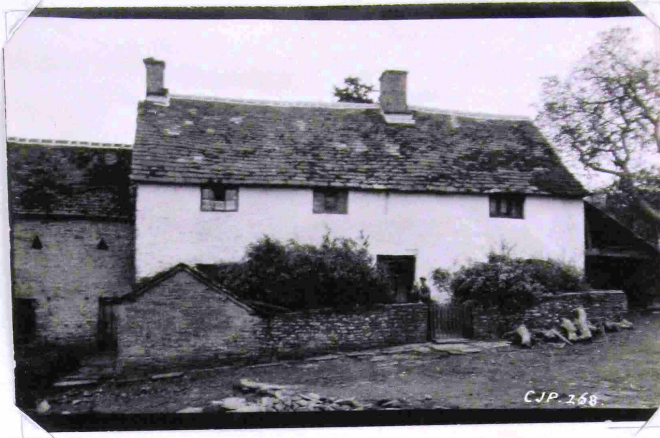
Door to Parlor has chamfered joints & square head with auxiliary arched head to frame beneath the latter.

Ceilings of ground floor rooms have exposed beams, those in west E room being stop chamfered, those in west W room plain, those in central room moulded roof section → in this room the joints also are exposed & chamfered & have spur stops.

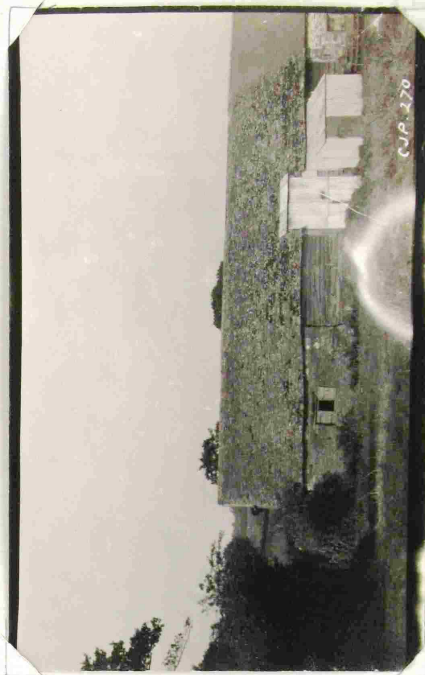
Ceilings of ground floor rooms have exposed beams.
