The History of Ewyas Lacy

Title: Digital Archive: Royal Commission on Ancient and Historical Monuments - Photographs of original survey particulars, Part 13 of 13

Part 13: Longtown

ELSG Ref RCAHM Records: Longtown

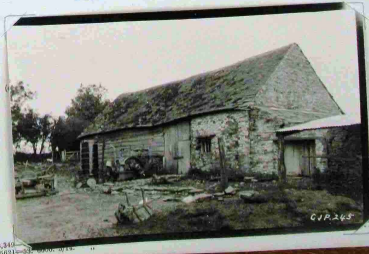
3. Historical development (with dates and small sketch plan):
a 17th c. barn. In modern times a lean-to roofed addition has been built on at West.

North Elev. Most interesting bay is gable rubble above a light diamond mullioned window. Remains timber framed on carved with modern siding.

South Elev. Uniform with N. Elev. but has a slit window in lieu of gable end.

East Elev. Gables. Stone rubble. In gable is a square opening with old timber frame modern slates. On ground level is a light diamond mullioned window.

West Elev. Gabled. Almost entirely concealed by lean-to.

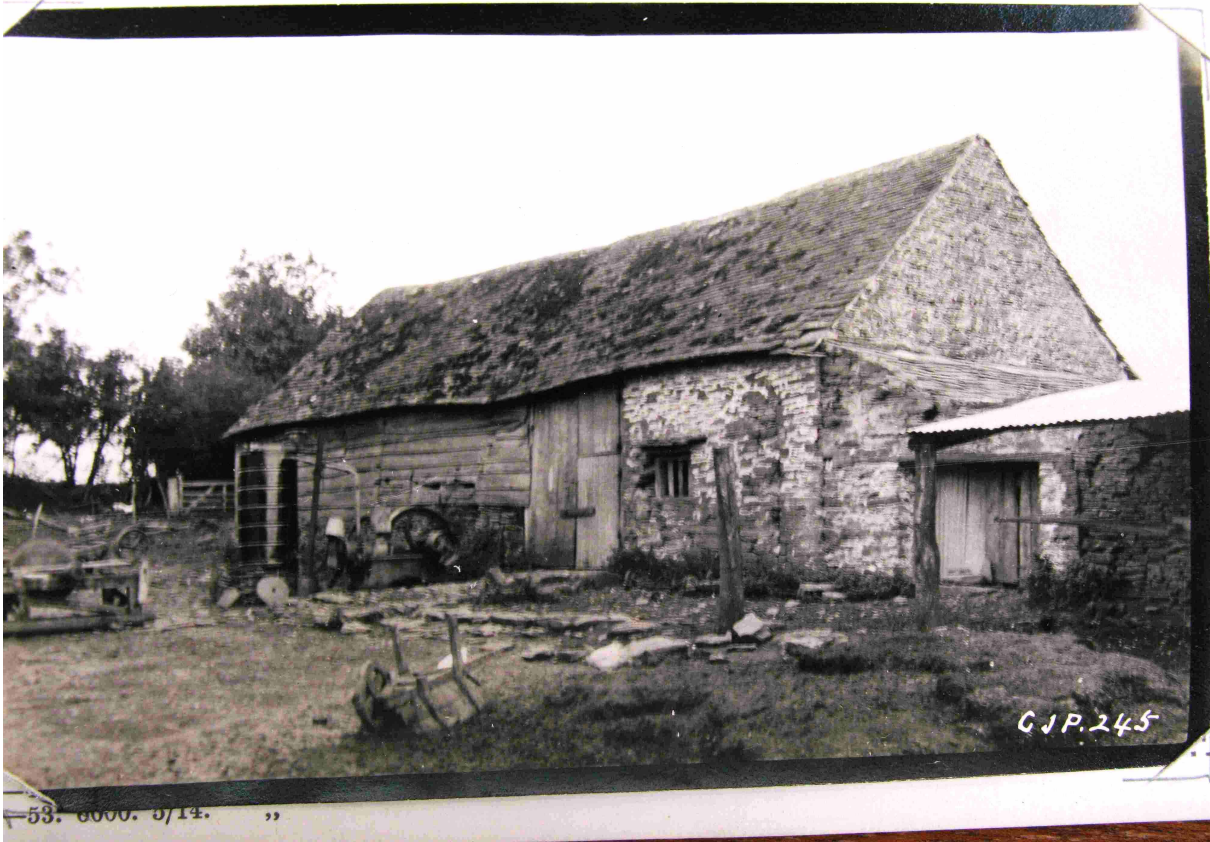
lean-to

S. Elev. Uniform with N side except that the double doors have dormer head + there is a modern 'lean-to' against two most westerly bays.

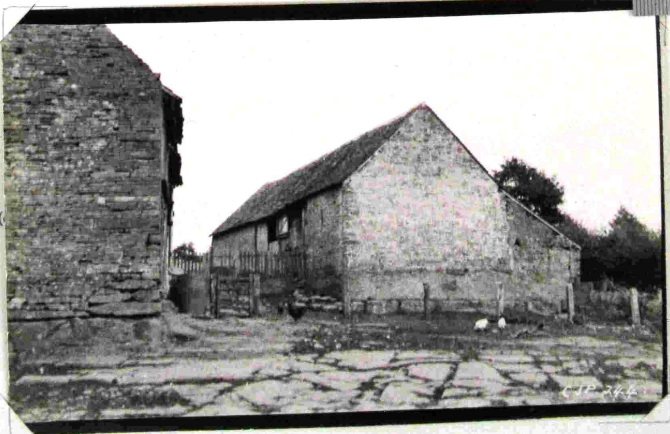
3. **Historical development** (with dates and small sketch plan).
A late 17th c. barn

N. Elev. Stone rubble largely re-built. Some exposed timber framing in one bay with slab stone infilling between framing. Two slit windows.

E. Elev. Gabled. Rubble stone. Old timber frame to opening in gable.

W. Elev. Stone. Gabled.

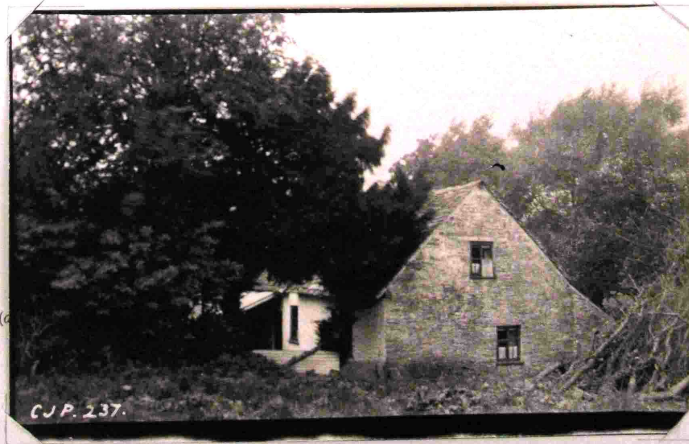
*an early 17th c. house.
late in 18th c. it was
extended towards the West.
modern additions built
on along N side & porch
small addition added
on S.*

*The house is gabled at E & W ends & there
is a domed window on S side. For the rest
it has been modernised & there is nothing
particular to note.*

*The central stack is of rubble stone & upon
a plan with its upper portion rebuilt.*

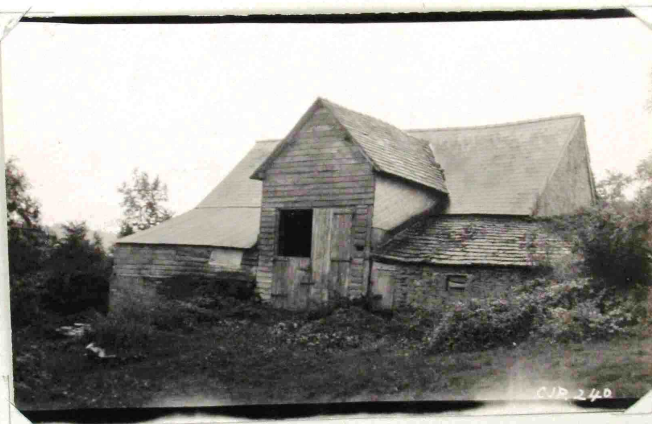
Internally divided into 4 bays by 3 roof trusses of type →

In 2 small E bays are two tie beams some 6ft above floor level which formerly probably supported a floor forming a small 'beast-house' at ground level, lighted by 2 slit windows in the N-S walls.

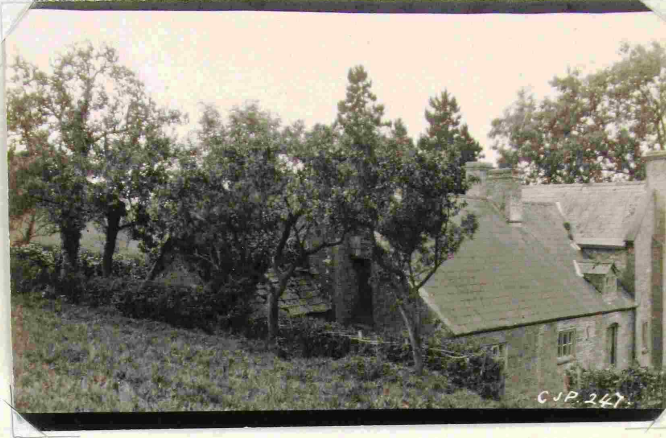
In central stack, on ground floor is a fireplace opening with square head & joints of chamfered stone. It has been partially blocked up.

Door from passage into room gold house has an old chamfered frame 17k.c.

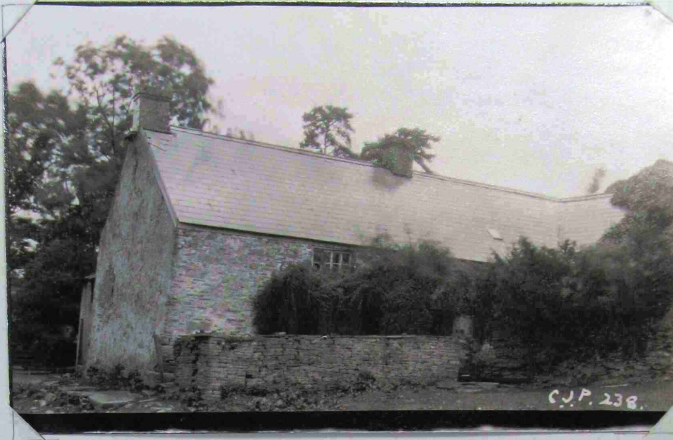
Ceilings of all ground floor rooms have exposed stop chamfered beams & also exposed joists.

Between central & east E room is a panelled partition.

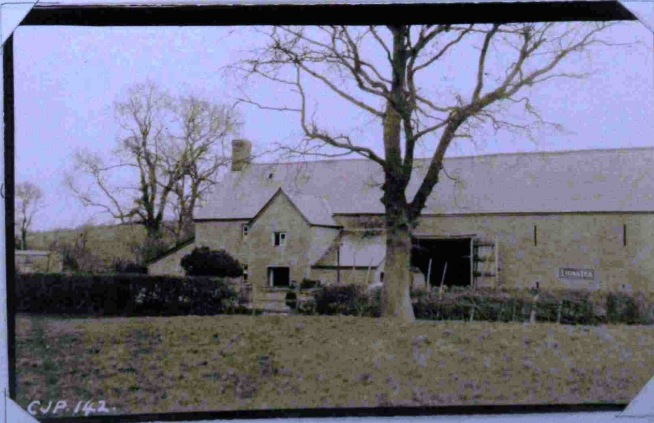
*East Elev. largely concealed. 1st floor of house has exposed
timber framing. On ground floor of barn are
2 blocked windows + slit windows above.*

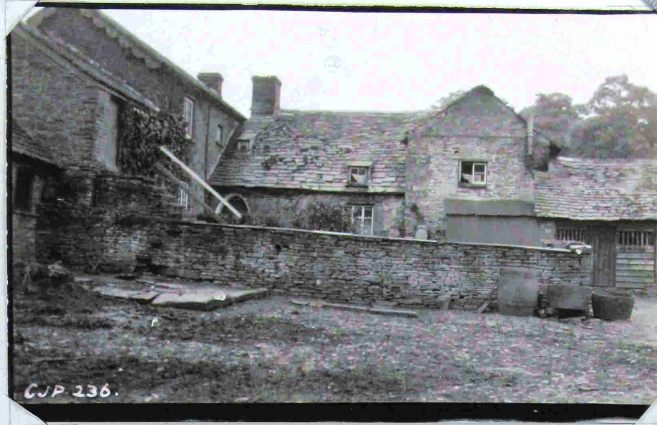
Ceiling of ground floor large room has exposed stop chamfered beams & exposed joists.

Framing to doorway between entrance vestibule room has a chamfered ogee head.
