The History of Ewyas Lacy

Title: Digital Archive: Royal Commission on Ancient and Historical Monuments - Photographs of original survey particulars, Part 2 of 13

Part 2: Craswall and Michaelchurch Escley

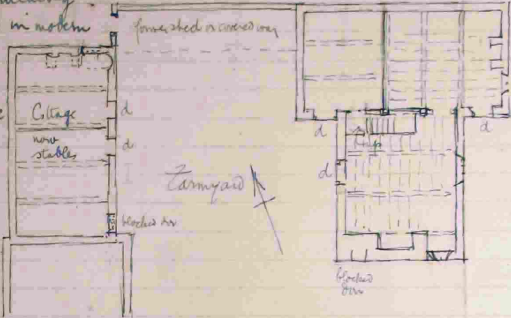
3. **Historical development** (with dates and small sketch plan).
The farmhouse is an early 17th century building of T shaped plan. It has been altered in modern times & some of its old oak removed. A rectangular building W of the house now stables was originally a dwelling house of the 16th century.

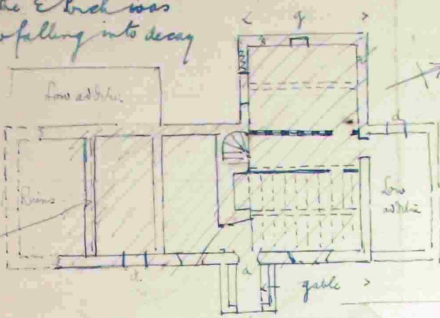
3. **Historical development** (with dates and small sketch plan).
*Probably a 16th. house of L-shaped plan; the E. block was probably a later addition. House now falling into decay half of it in ruins.
Name 'White Oak' derived from an old tree standing E. of the house*

5. **Elevations:** (Begin with the main front, and mentioning, in the following order:—(a) Walls; (b) Gables; (c) Doors; (d) Windows; (e) Chimneys; (f) Rainwater heads and pipes.)
*E. front. Central porch with little to date: now roofless. Internal doorway oak framed. windows have modern frames: S. half of wall in ruins.
Central chimney; square stone stack.
S. end ruin: timbered roof over gable end on former internal truss.
W. wing has an old chimney stack to gabled W. wall and in the S. wall an old oak frame to a blocked window. This wing has bad gaps in the S. wall and splits in the N. & W. walls.*

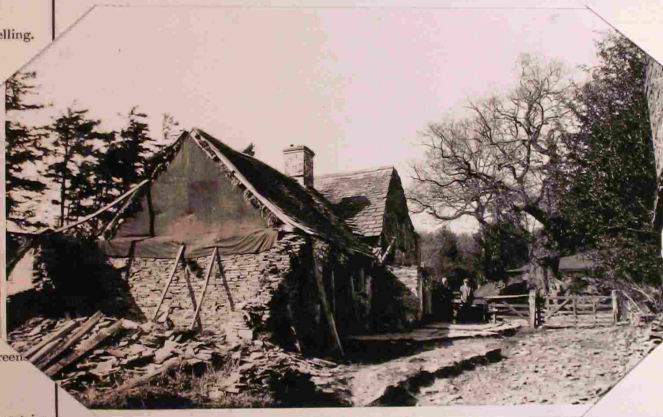
A fine long strip of early 17th c. fluted fringe in oak now loose is probably indigenous but its original position not known.

8. **Condition:** Only part inhabited: the S end in ruins, cracks & gaps on the NW wing & the E porch roofless.

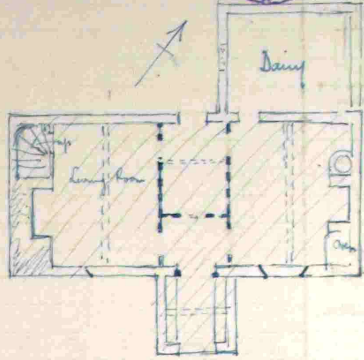
3. **Historical development** (with dates and small sketch plan).
A 16th-century house of rectangular plan with a central porch-wing on the S.E. front

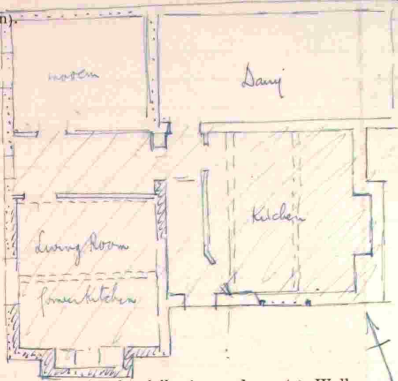
3. **Historical development** (with dates and small sketch plan).
Probably a 17th c. house of L shape originally. The original kitchen probably only one storey or one storey and attic. This wing (the W.) altered in modern times to a two-storey main block the former living room in the E wing being now the kitchen. The dairy, a low back addition probably 18th century.

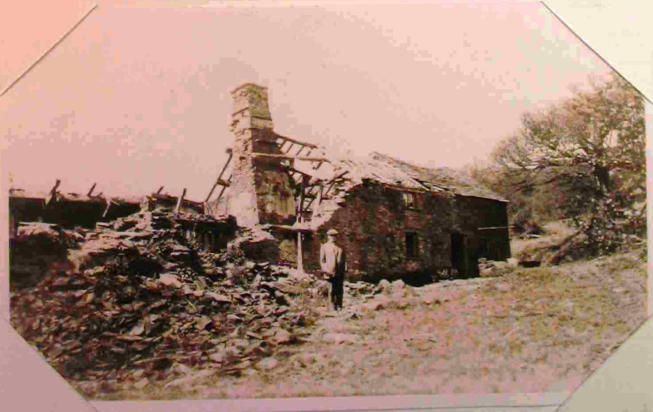
3. **Historical development** (with dates and small sketch plan). *The house was an interesting one, probably of the 16th century - of L shaped plan but during the last generation it has been vacated and allowed to fall to ruin.*

5. **Elevations:** (Beginning with the main front, and mentioning, in the following order:—(a) Walls; (b) Gables; (c) Doors; (d) Windows; (e) Chimneys; (f) Rainwater heads and pipes.)
*E. front: stone: doorway stone jamb oak lintel: S of it a window opening with square oak frame and five oak mullions square set diagonally.
 S. wall nearly in ruins. W. wall has a projecting over modern doorway
 E. end stables continuing lines & height of the house: gable end.
 Central chimney stack to N. wing with plain square top.*

8. **Condition:** In ruins: piles of stones & broken timbers lie about the site

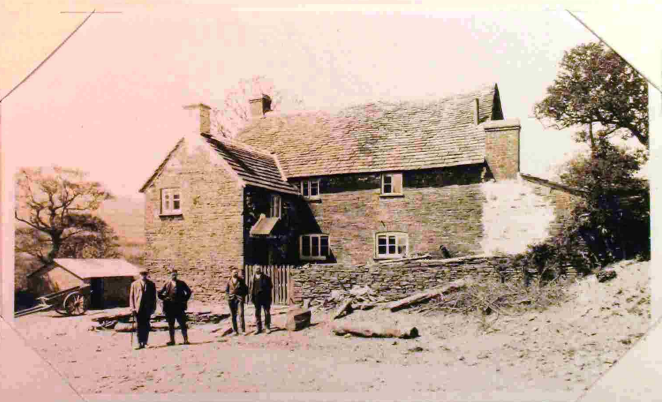
3. **Historical development** (with dates and small sketch plan). *The old timberwork inside suggests a 16th century origin to a rectangular plan with two rooms on each floor. The external stone walls with their wood windows and door frames are modern. It is possible the house was originally a wholly timber framed one excepting the E. stone chimney stack. The S. Porch is modern.*

5. **Elevations:** (Beginning with the main front, and mentioning, in the following order:—(a) Walls; (b) Gables; (c) Doors; (d) Windows; (e) Chimneys; (f) Rainwater heads and pipes.)
*Walls of sialy stone rubble (local) and all doors & window frames modern
 Chimneys of modern brick*
