# The History of Ewyas Lacy

**Title:** Digital Archive: Royal Commission on Ancient and Historical Monuments - Photographs of original survey particulars, Part 3 of 13

Part 3: Craswall and Michaelchurch Escley

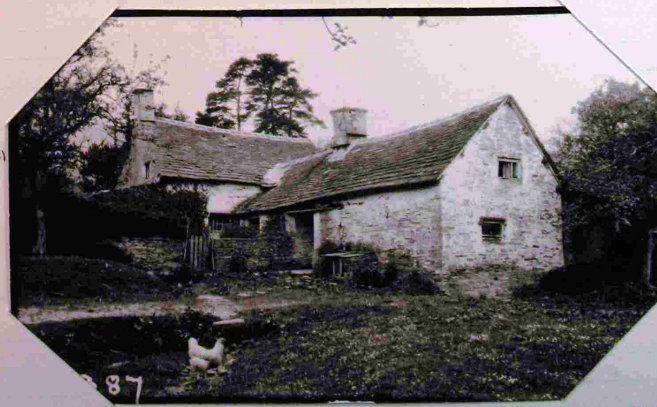
1. Name and situation of Monument (with owner's Name and Address). *White Baywood Farm  
1 1/2 miles E.E. of church*
2. General appearance: (a) No. of storeys. *Two*  
(b) Building materials. *Stone rubble walls*  
(c) Roofs. *Stone slabs*

3. Historical development (with dates and small sketch plan).  
*The date 1635 on the doorhead in the partition between the two wings of the L shaped plan probably marks the age of the whole building, altho' there is some slight suggestion that the longer and lower wing projecting to the E. is somewhat earlier than the other which fits the date mentioned.*

*The walls are of shaly local stone rubble, and the central chimney of the E wing and S. end chimney of the W wing are old stone square stacks.  
The window frame in the E wall of the W wing is of 1635 and is of four lights with ~~old~~ moulded frame and mullions of oak. The other windows have plain oak frames excepting that at the E. end of E wing on the ground floor, which has a square frame and four mullions set diagonally and the window above this which had three similar mullions of which one remains in place.  
The outer doorways are of modern repair.*
