# The History of Ewyas Lacy

**Title:** Digital Archive: Royal Commission on Ancient and Historical Monuments - Photographs of original survey particulars, Part 4 of 13

Part 4: Llanveynoe

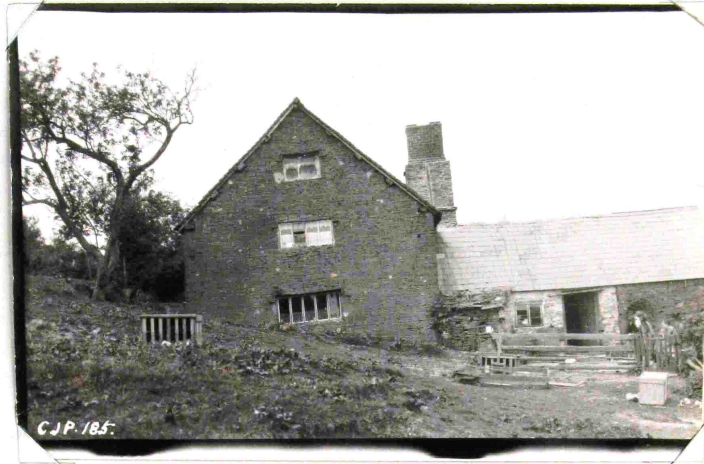
On ground floor is framed partition with stop chamfered posts or wood panels between.  
 In same partition is doorway with head of framing moulded as in sketch on same is hung on strap hinges a battered door.

Ceilings of ground floor rooms have stop chamfered beams exposed joints.

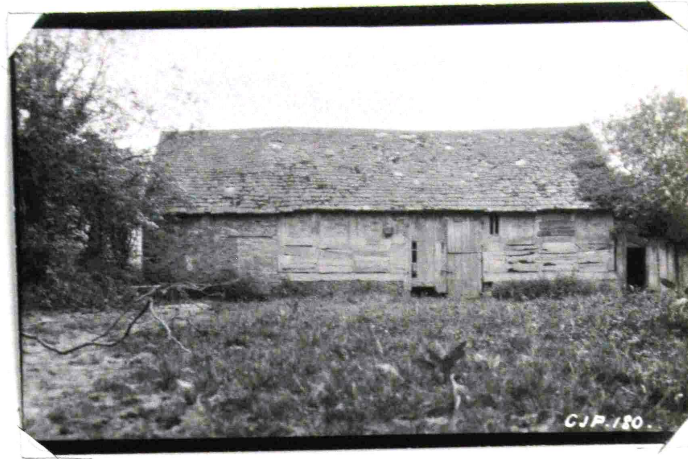
The two cross-partitions are of form →  
while two roof trusses are of type →
