# The History of Ewyas Lacy

**Title:** Digital Archive: Royal Commission on Ancient and Historical Monuments - Photographs of original survey particulars, Part 5 of 13

Part 5: Llanveynoe

**ELSG Ref RCAHM Records: Llanveynoe**

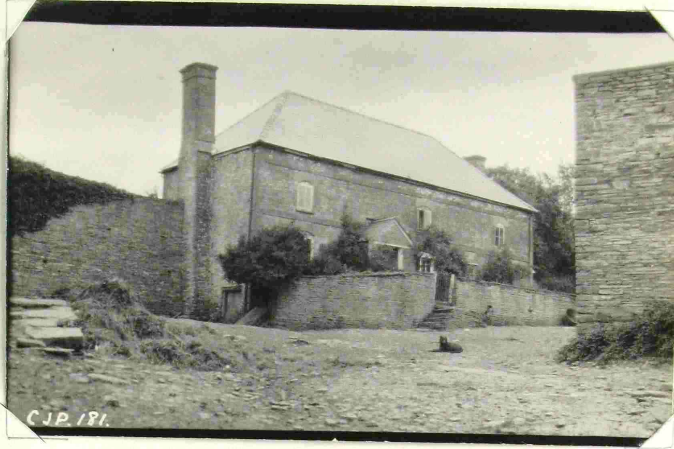
*Ceilings of ground floor rooms have exposed stop (moulded) chamfered beams, the joists also being exposed in most of room. Ceiling of entrance hall has exposed joists. On 1st floor the old tie beams (stop chamfered) remain with later roof timbers super imposed.*

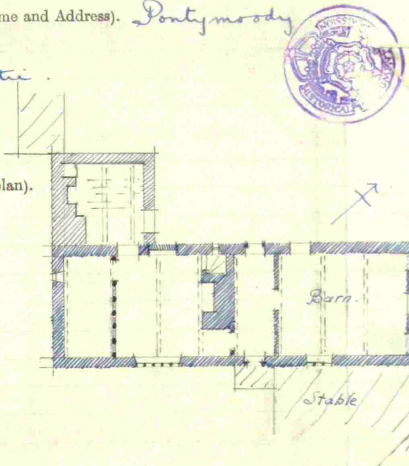
*A mid 17th c. house. The N.E. portion of which is now used as a barn but which originally formed part of dwelling house. c. 1700 the wing was added. In modern times a stable has been built on against S.E. wall of barn.*

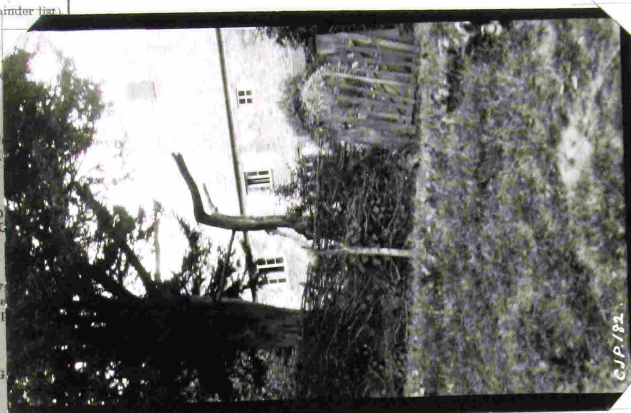
Between room & dairy is a panelled partition with stop chamfered posts. In same is doorway with segmental head.

Ceilings of ground floor rooms have exposed stop chamfered beams. Ceiling joists are exposed in the wing.

In main room there is a cupboard with battened door with moulded planks >

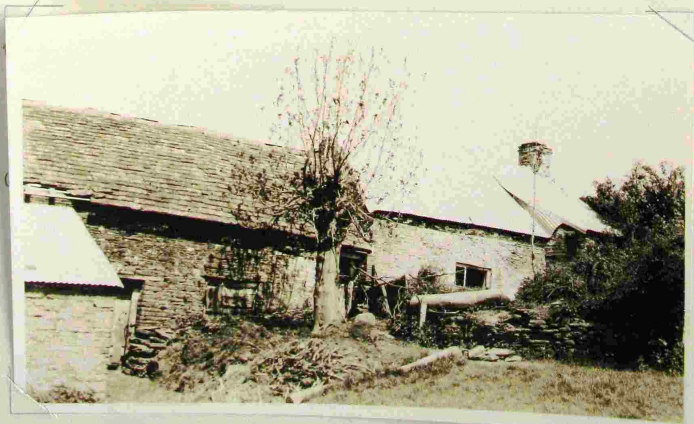
1. **Name and situation of Monument** (with owner's Name and Address). *Wern Farm (described as barn) 1/4 mile S of Church.*

2. **General appearance:** (a) No. of storeys. *1 + attic.*  
 (b) Building materials. *Stone rubble.*  
 (c) Roofs. *Stone on S.E. Cor. Iron on N.W.*

3. **Historical development** (with dates and small sketch plan).  
*a late 16th or early 17th c. house. In modern times a barn has been built on at S.W. end.*

*N.W. Elev. Two ground floor windows have old wood frames + flag stone projecting labels.*  
*N.E. Elev. Gabled. Exposed timbers. There is a projecting outside stack to 1st floor with rectangular base supported on stone corbels and square stone shaft with projecting cap. There is a window at 1st floor level with old wood frame.*  
*S.E. Elev. On ground floor is a blocked window or window with old wood frame. There is a lean-to roof projecting bay containing a semicircular stone staircase.*  
*S.W. Elev. Gabled but mostly hidden by barn.*

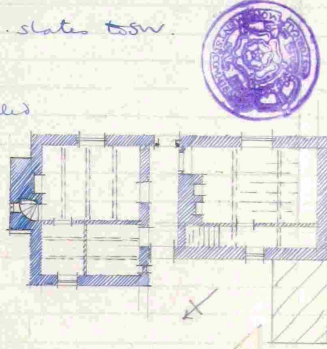
3. **Historical development** (with dates and small sketch plan).  
*Probably built <sup>between 16th or early 17th</sup> 1600 but re-modelled later in the century. This would appear to have been more re-modelling late in 18th when possibly the S.W. portion was raised & also in more modern times.*

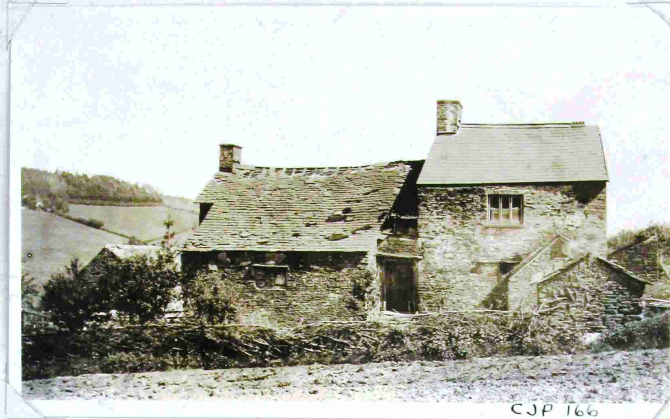
In N.E. room are 3 battens doors, hung on strap hinges.  
Ceilings of ground floor rooms have exposed stop chamfered beams some exposed joints in S.W. room.

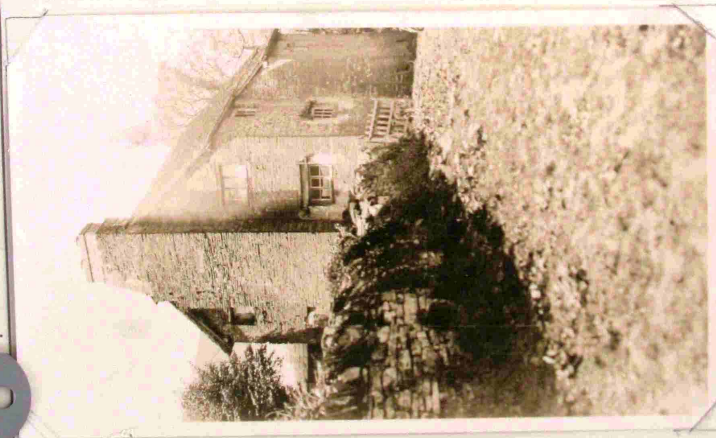
On ground floor all partitions are wood panelled as described under "S. Elevation".  
 The framing above all doors is segmental & there are 3 (17thc?) batted doors hung on strap hinges. Ceilings of all ground floor rooms have chamfered beams with 'spur' stops & exposed joints, the latter in the large room being stop chamfered. The dairy window has inside batted shutters hung on strap hinges & staircase window has one piece shutters hung on staples.  
 Gills of windows Window boards are of 5" oak slabs.  
 On 1st floor ceilings have chamfered beams with moulded stops & plain exposed joints. There is an old wood beam over modern fireplace in bedroom.  
 Window boards similar to those downstairs.

8. Condition: Fair.

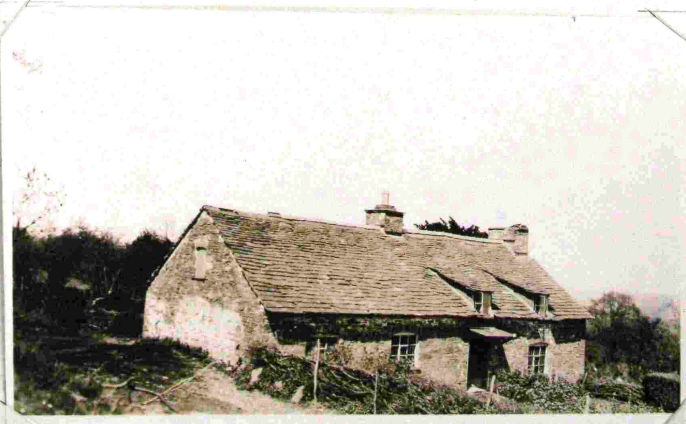
*W. Elev. Gabled with exposed timber. There is a square stone central stack with projecting string & stepped stone weatherings to sides & a projecting stone cap.*

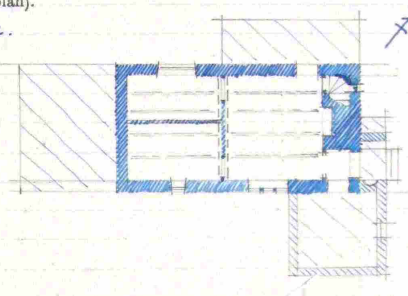
3. Historical development (with dates and small sketch plan).  
*late 17th c. house. Late in 18th c. a barn was built on at S.W end, a lean-to on N.W side + a new wing + porch at E angle.*

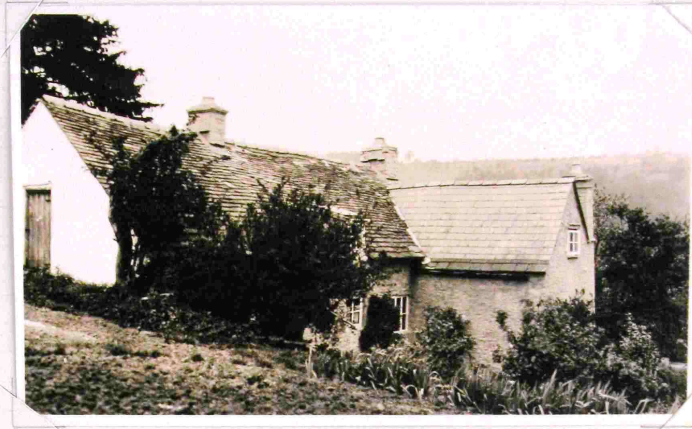
Party window internally has old strap hinges of former shutters now replaced by modern ones.  
 On ground floor are 3 battened doors of which two have moulded planks  
 The stone staircase has wide slab oak treads.  
 In ceiling above partition on ground floor is a stop chamfered beam supporting four heavy scabbling stop chamfered joists or sub-beams.

8. **Condition:** *Good.*
